Darlington Borough Council

BUILDINGS AT RISK REGISTER February 2008

'BUILDINGS AT RISK' REGISTER 2008

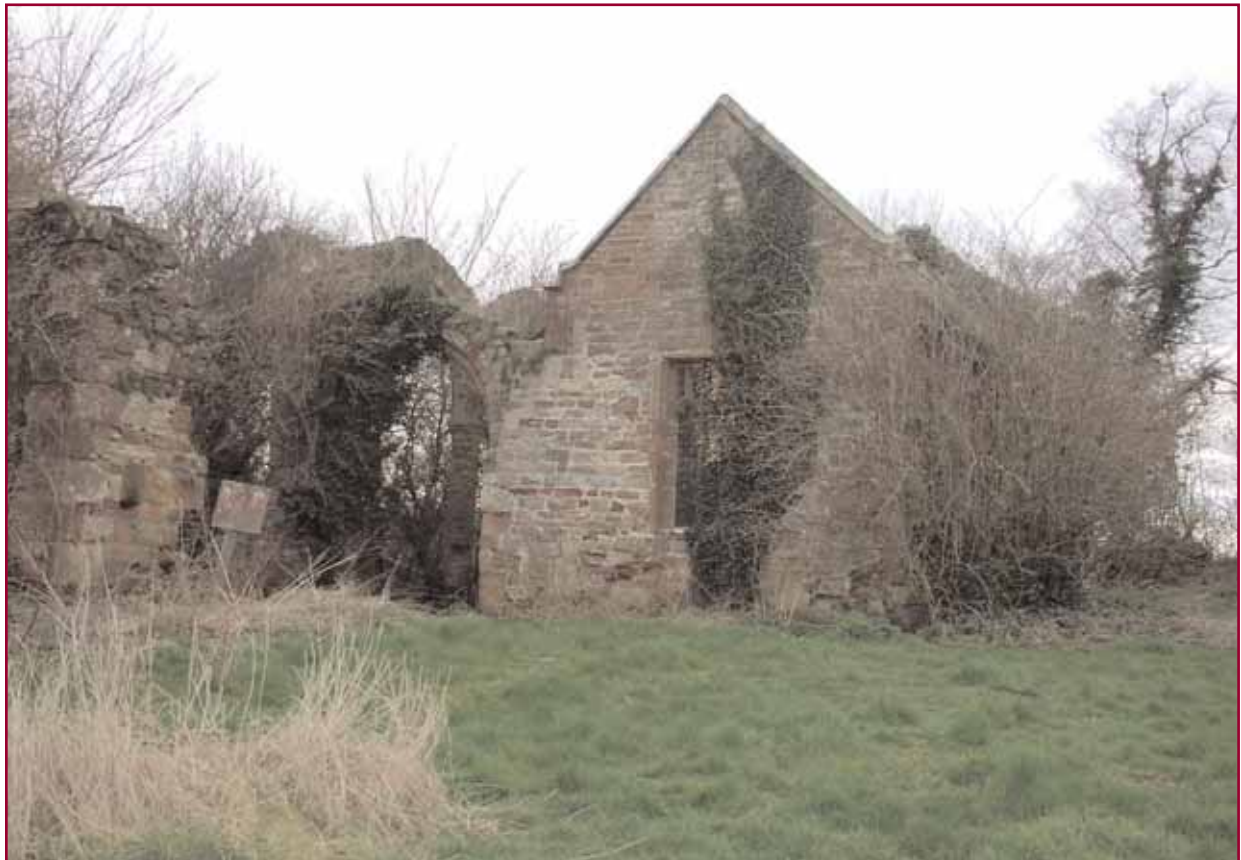
All Saints Church

Ruined church. Pre-Norman nave and chancel; late 12thC south aisle; the chancel was rebuilt in the early 13thC; 14thC chantry, now the Conyers chapel; the latter was restored and re-roofed in 1900 by WH Knowles; chancel roofless.

Funding has recently been offered by the Church Commissioners for Durham diocese and English Heritage, for the replacement of the roof, which would greatly assist in consolidating this important mediaeval building.

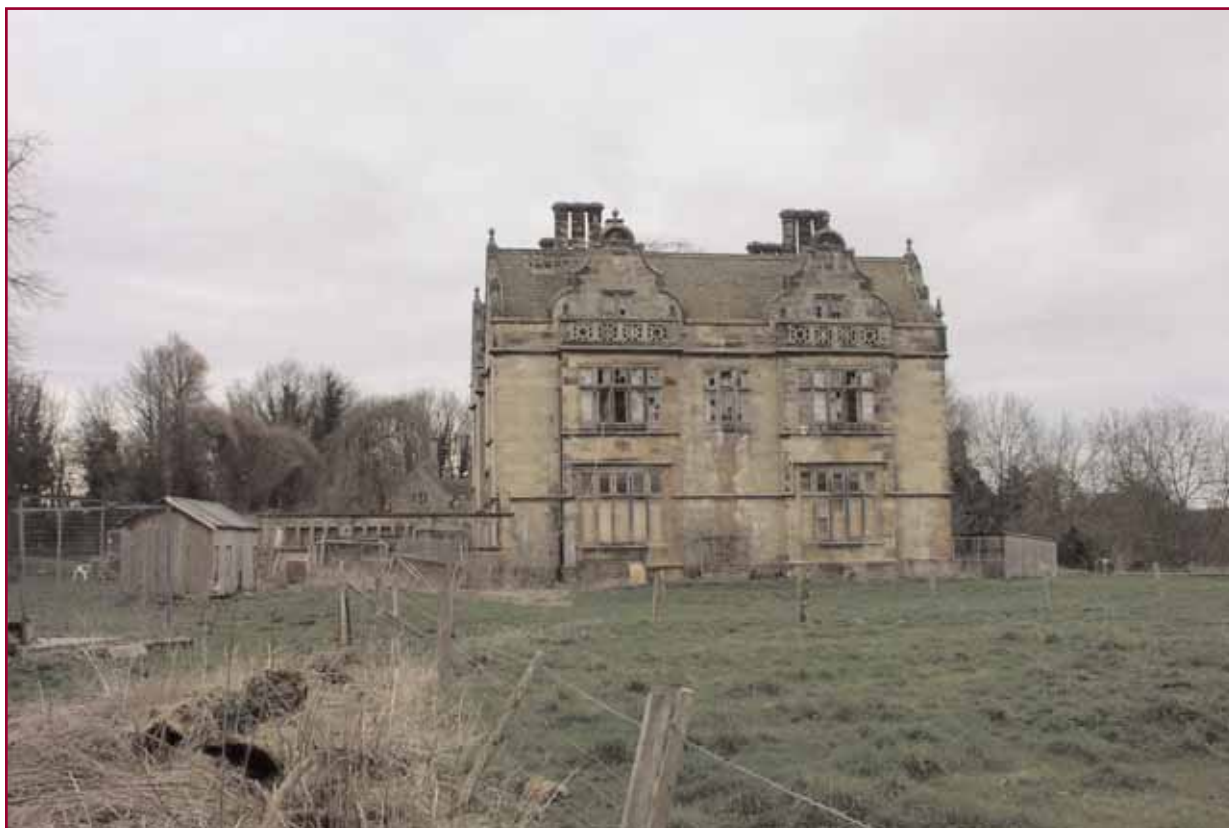
Sockburn Hall

This property has been vacant for several years and suffered a collapse of a number of roof and floor timbers due to water penetration. The owners are now looking to retain the building.

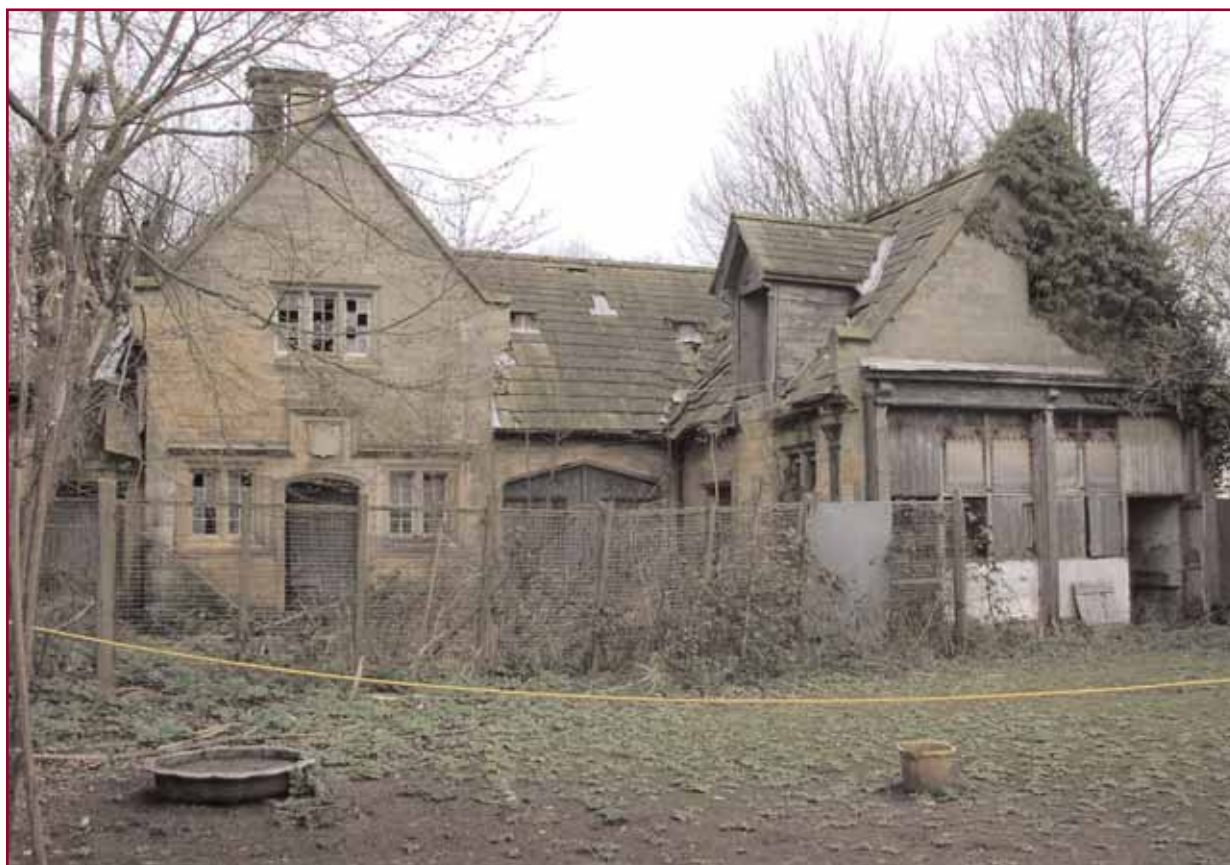
Former Coach House to Sockburn Hall

Currently vacant, dilapidated, missing roof tiles and with serious water ingress, the building in association with Sockburn Hall is being retained by the owners.

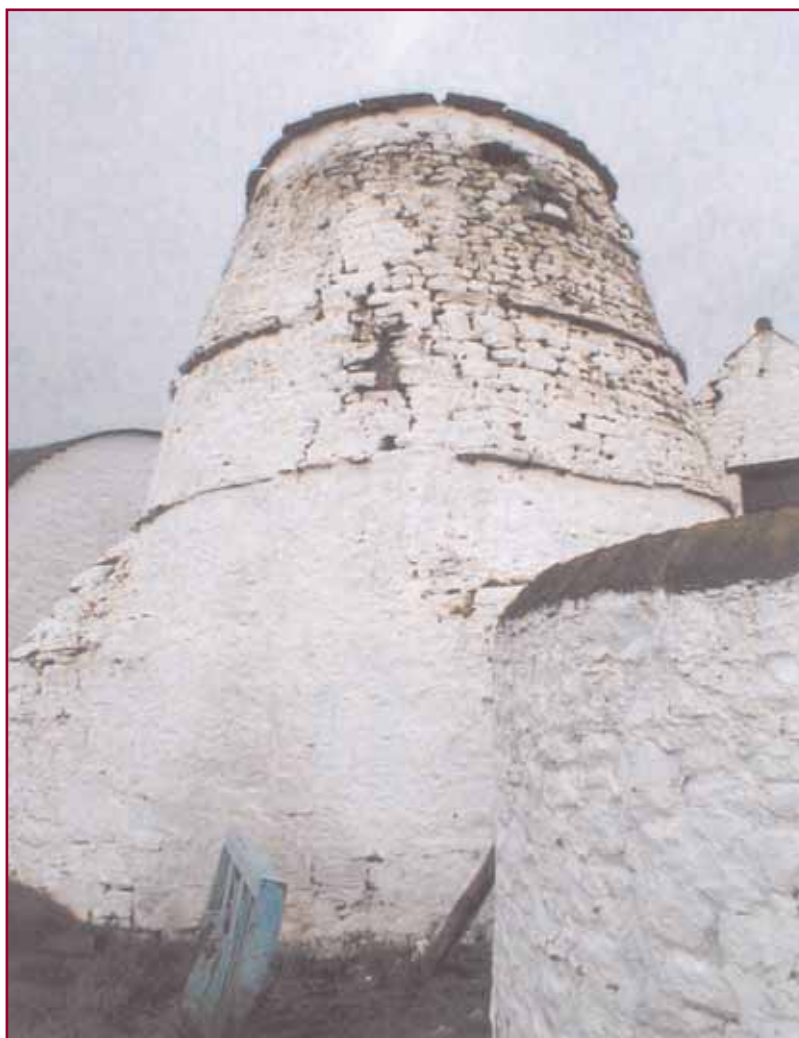
Dovecote, 45 metres east of Manor House Houghton Bank Lane, Houghton-le-side

Considered one of the largest and best examples in County Durham, a new use would be exacerbated by its awkward shape and location.

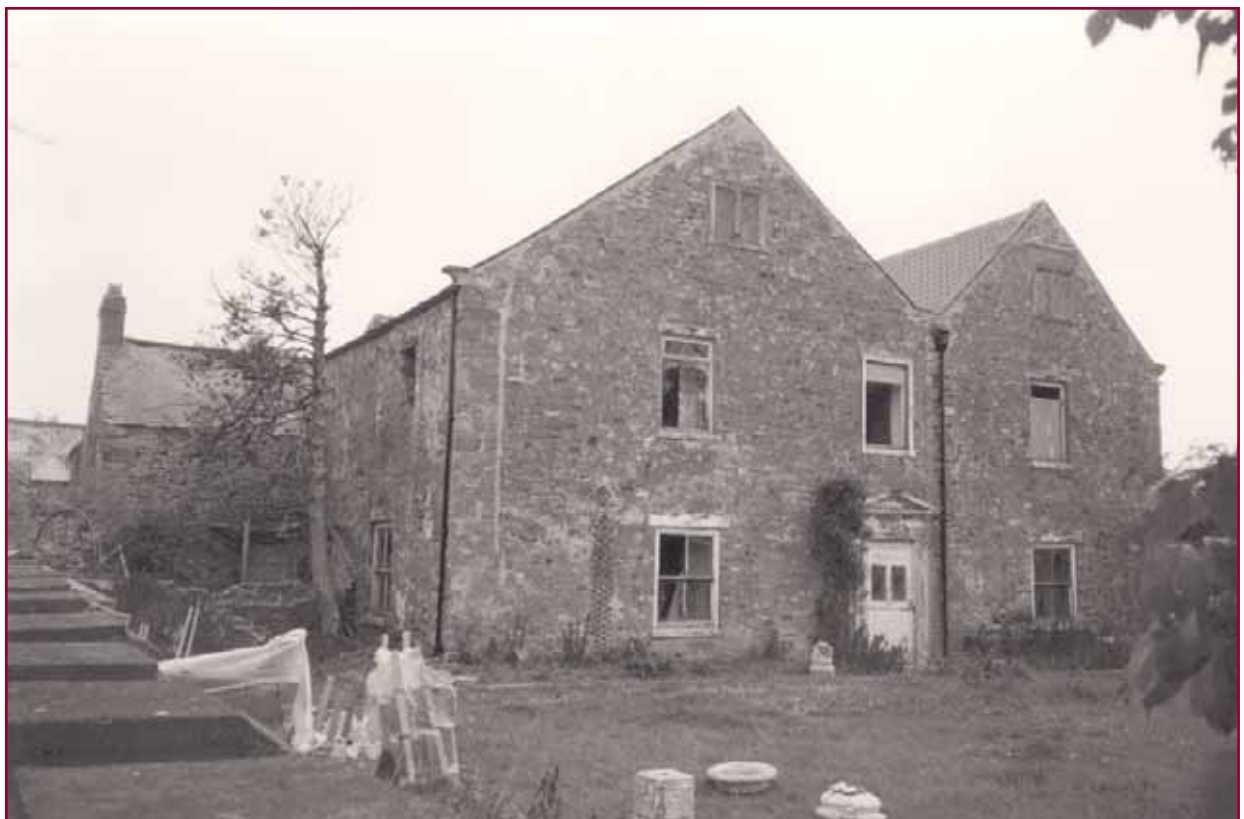
Midridge Grange Farmhouse

Large farmhouse c.1600, with alterations and additions from around 1690, 1720, 1850 and 1897. Partly rendered coursed sandstone rubble; Welsh slate and clay pantile roofs, the latter with stone-flagged eaves. Currently vacant and identified as being at risk since 1997, English Heritage has recently provided grant aid towards the preparation of a condition survey and outline repair proposals.

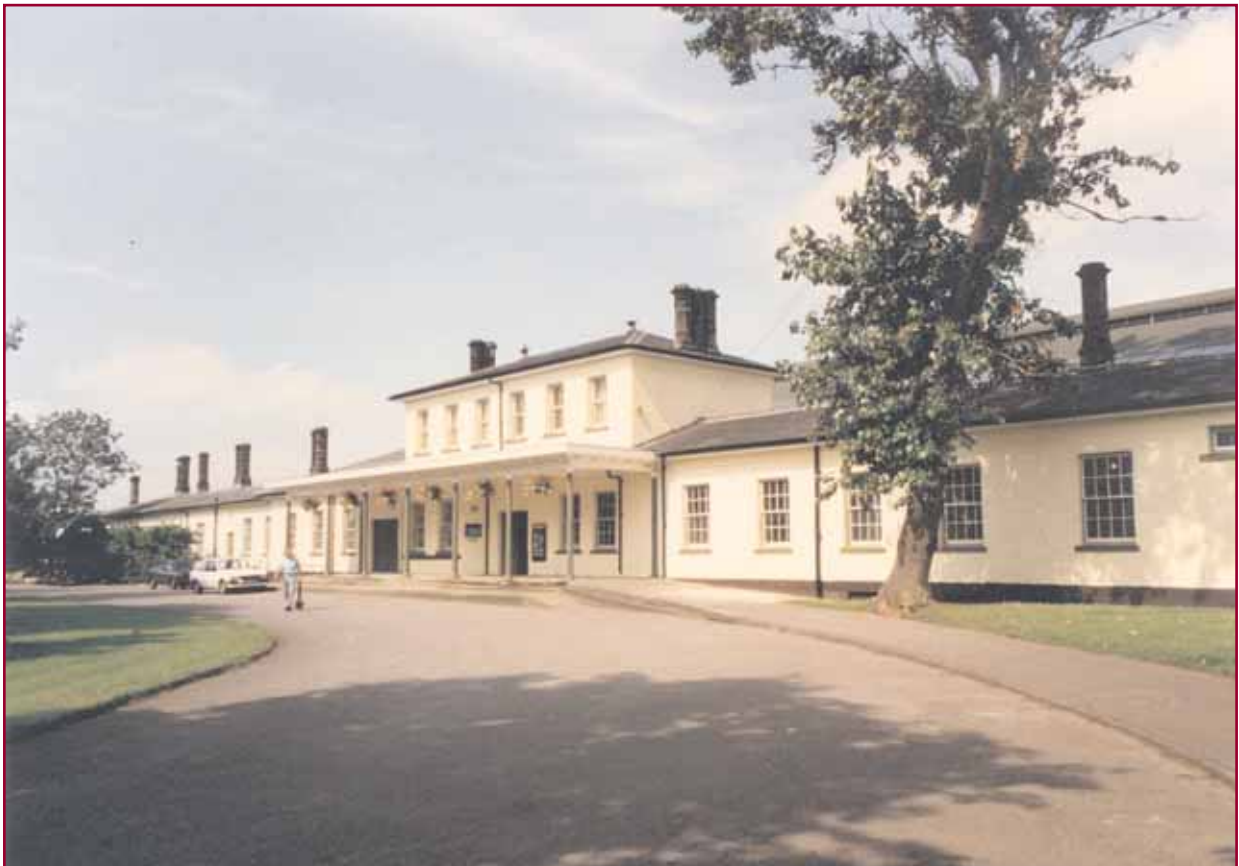
North Road Railway Station

Railway Station, opened in 1842, with later amendments/additions. Served the original Stockton & Darlington Railway. Now used as a Museum as well as a public station. Poor maintenance resulted in serious structural decay of the roof trusses. Following an English Heritage-funded conservation plan, a repair solution was agreed and a major EH grant offered in April 2006 towards re-roofing the station. The building is due to open to visitors following a refurbishment programme, in April 2007.

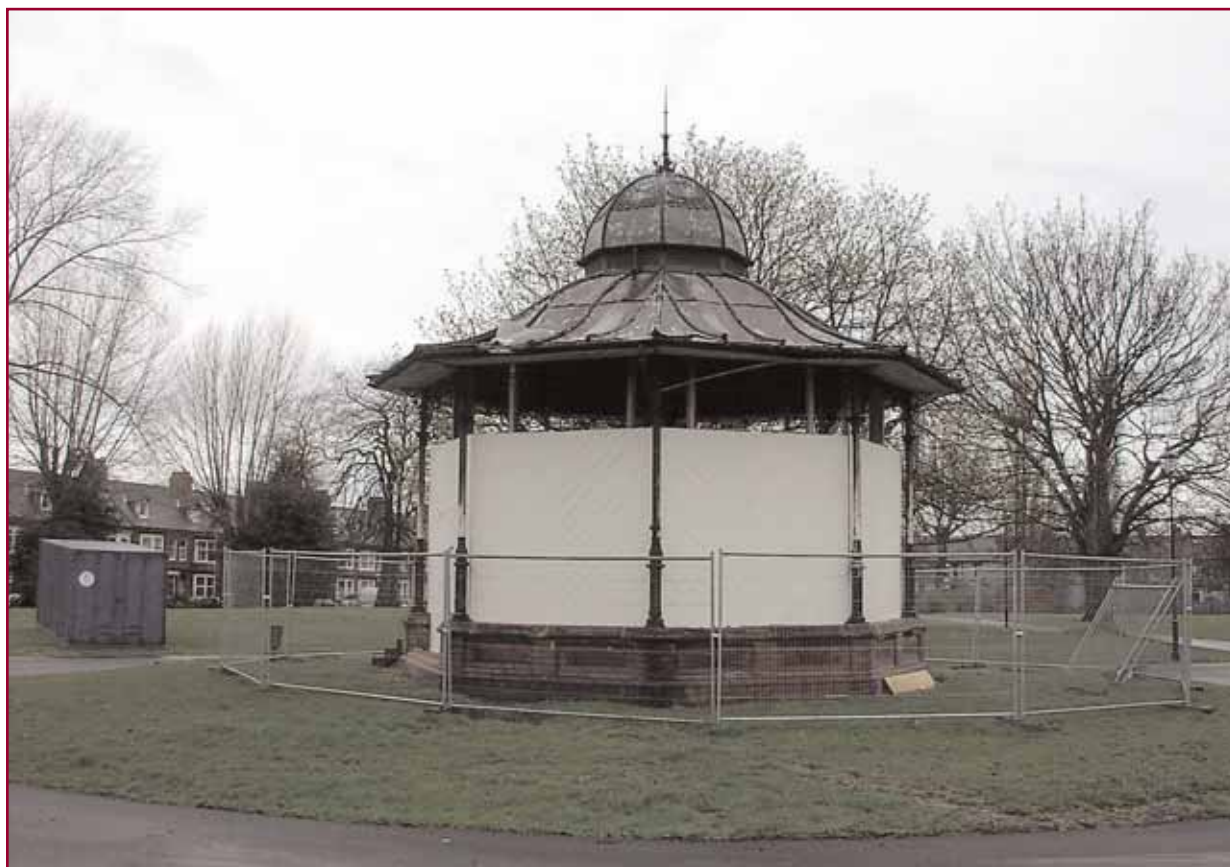
Bandstand in North Lodge Park

This building has suffered some vandalism, including attempts to remove the zinc roof cladding. The interior of the bandstand is boarded off, with a ring of temporary fencing around it. A local 'Friends' group is seeking funding for the building's complete restoration and re-use as a music and community venue.

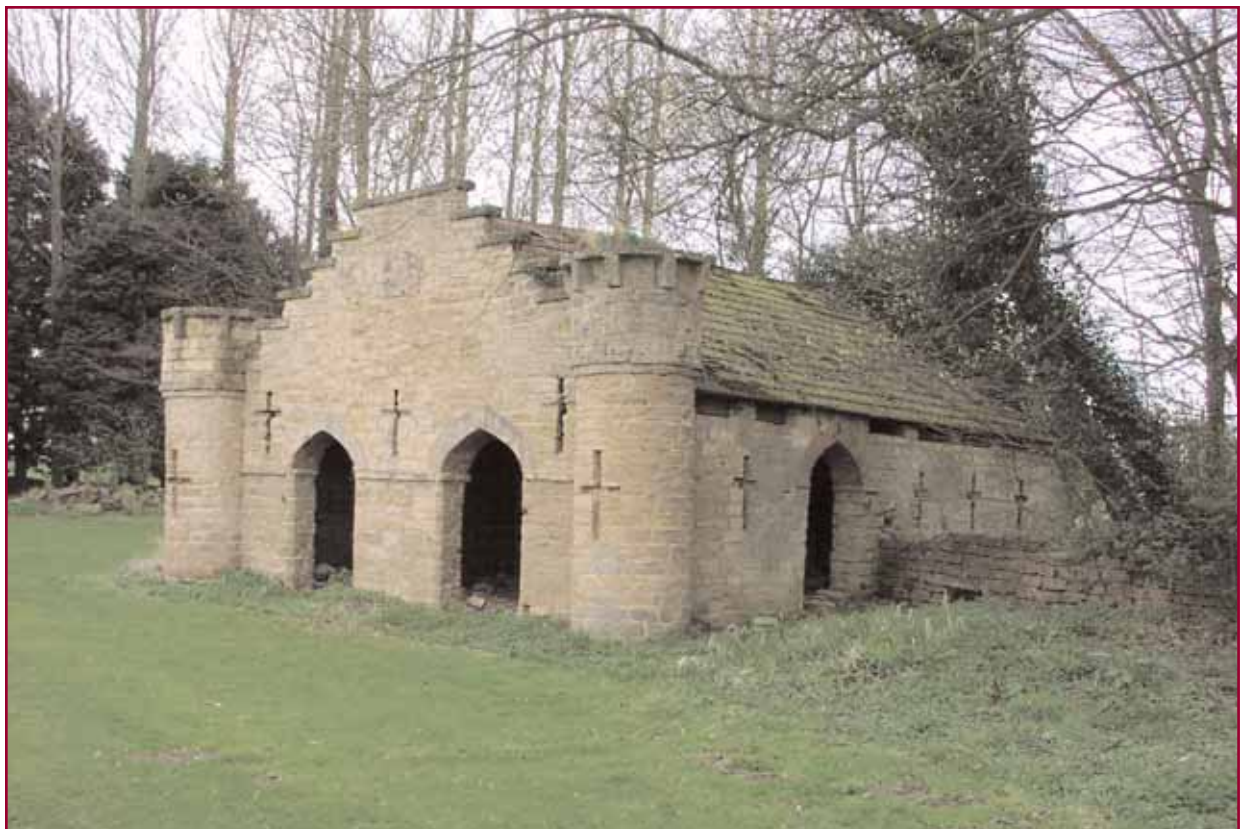
Deer House to South side of Hall Garth Coatham Mundeville

Although having recently been re-roofed, some serious structural cracks are visible in the right hand elevation wall.

Discussions have recently taken place between the Conservation Officer and new owners, and measures to repair structural cracks caused by subsidence have been agreed.

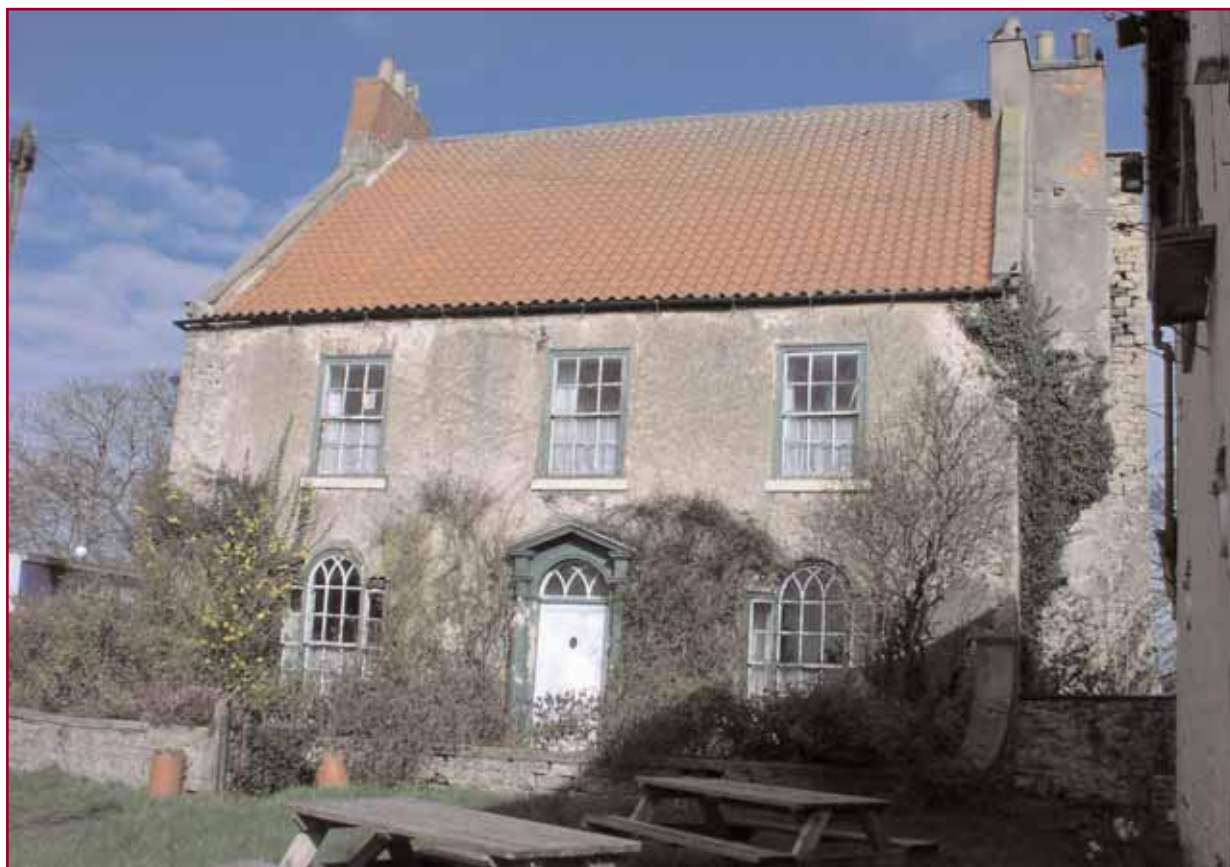
Glebe Farmhouse, Coatham Mundeville

Currently in need of significant maintenance, with wooden lintels above some windows failing; serious loss of mortar pointing in a number of areas, and right hand external chimney-stack suffering from serious stonework erosion.

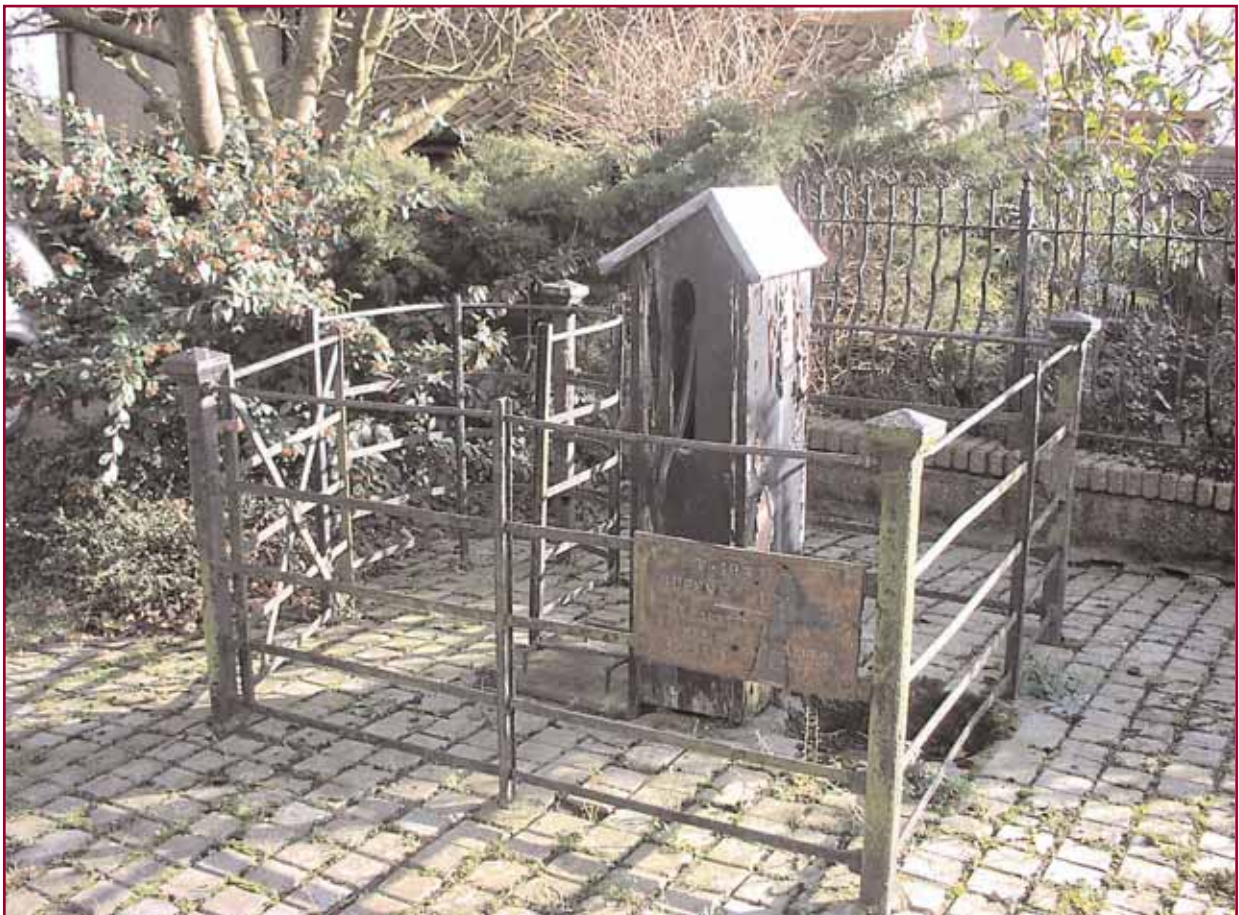
Water Pump & Railing The Green, Great Stainton

Built to commemorate the Golden Jubilee of Queen Victoria in 1887, this ornamental water pump with its surrounding cast and wrought iron railings is steadily deteriorating. The wooden case in which the pump is housed is rotting badly in places, and in need of some replacement boards. The steel plaque, which highlights the event, has cracked in two and has erosion of the raised lettering.

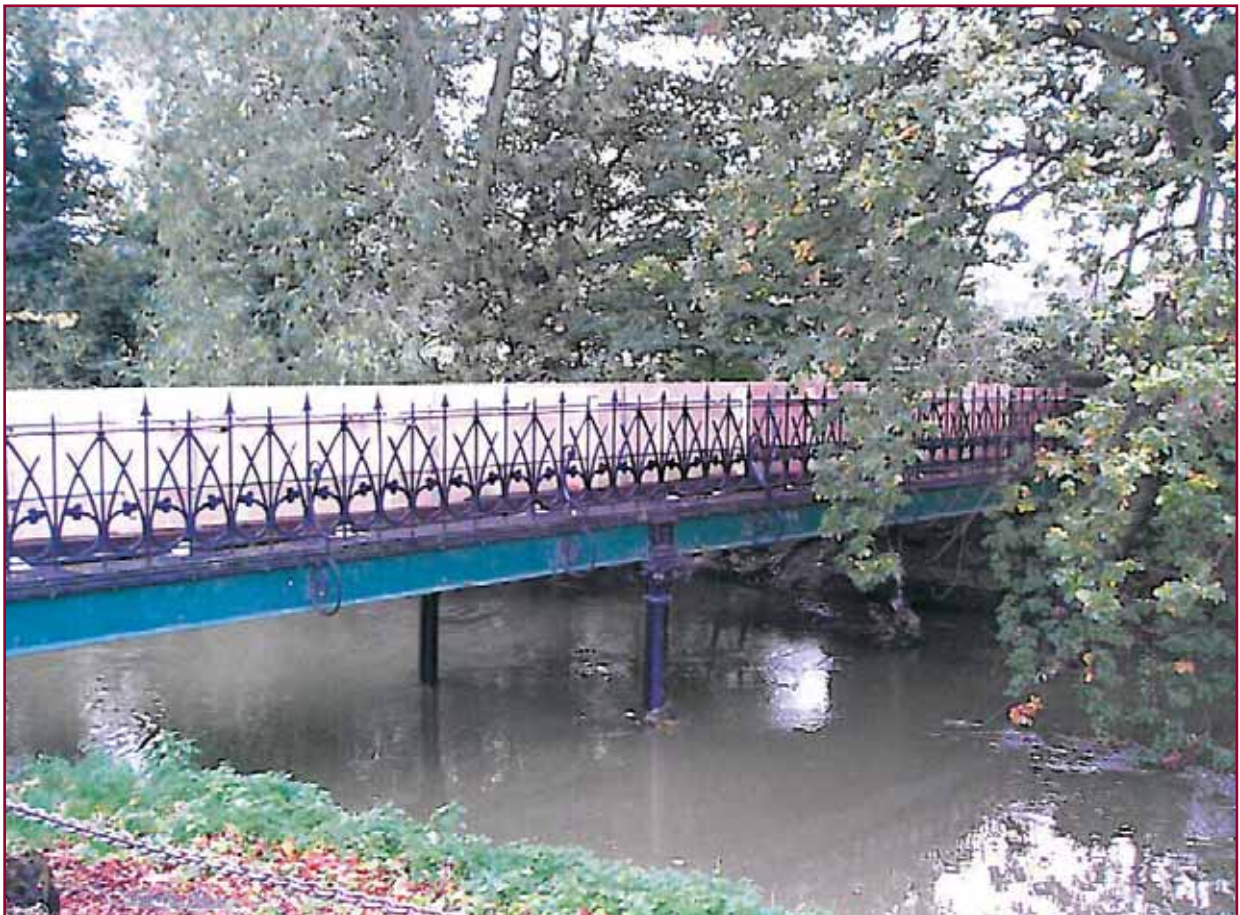
Polam Lane Bridg Darlington

Footbridge spanning River Skerne, built c.1891 of cast and wrought iron. North and South sandstone abutments. Built in association with South Park, the elaborate wrought iron ornamental handrails are themselves an attractive feature. The steel beams supporting the footpath are corroded and in need of replacement."

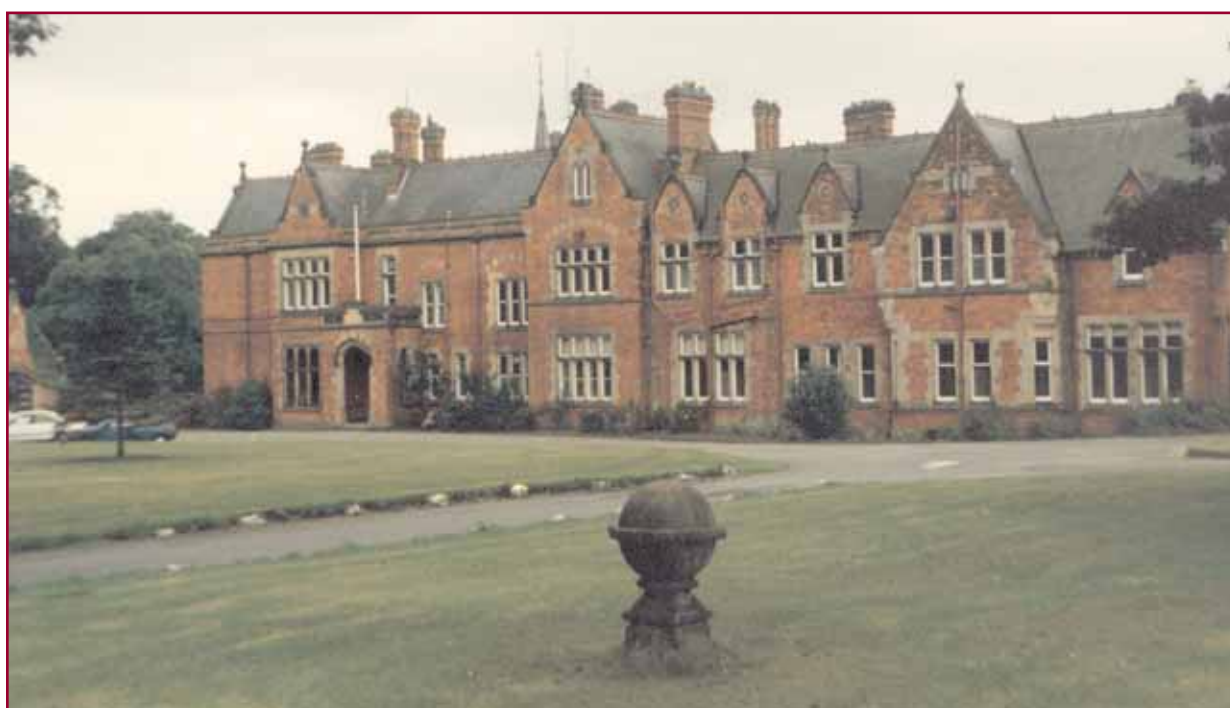
St. Cuthbert's Hospital in Rockcliffe Park Hurworth Road, Hurworth

This building suffers from water ingress caused through roof tile slippage, with resultant damaged ceilings/floors, with some vandalism and a general lack of maintenance. A new scheme of enabling development, allowing the building to be restored and re-used as a hotel, is going through the planning system, with minor changes to the listed building.

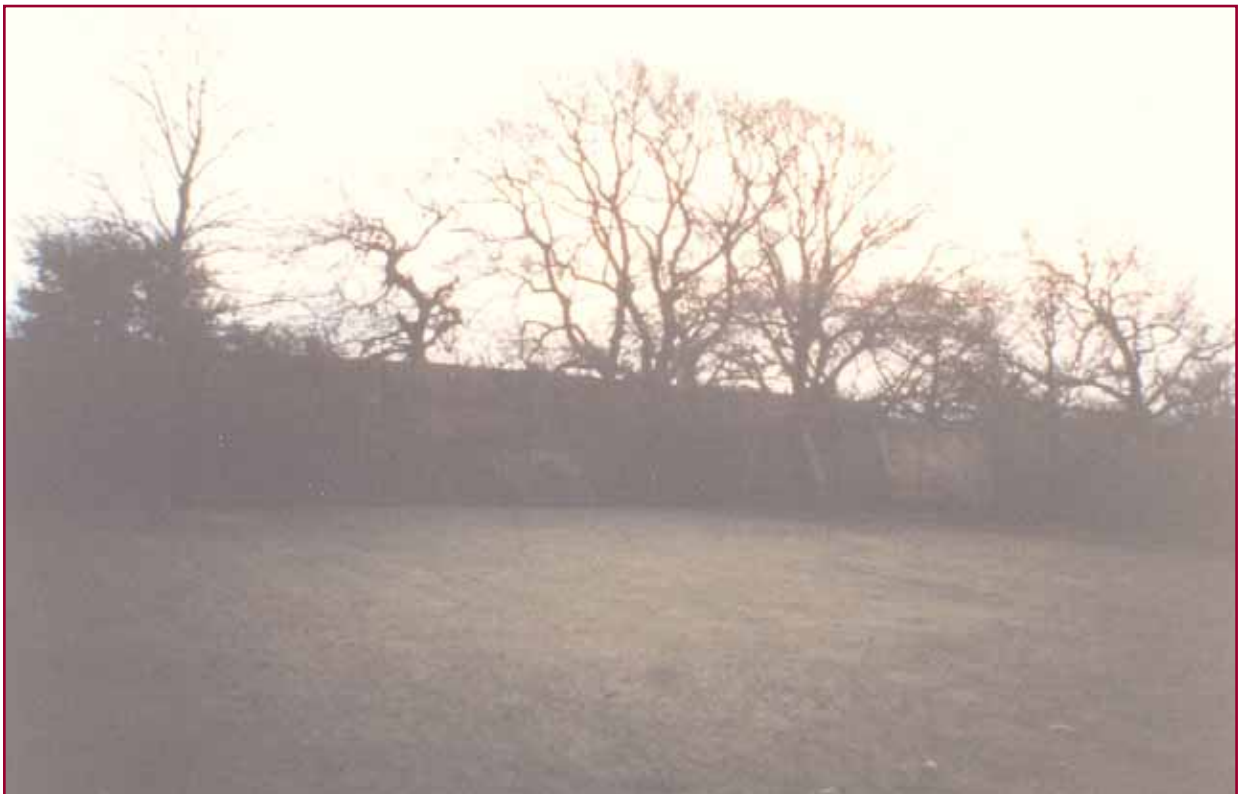
Outer Wall and Gate Piers, East of Middridge Farm Heighington

Garden wall and pair of gate piers, 2.5-3 metres tall, broken down and partly rebuilt in places; probably late 17th-Early 18thC. Coursed rubble walls with ashlar piers; walls enclose an L-shaped area known as The Bull Park.

It is hoped the walls will be restored following the restoration of Middridge Farm.

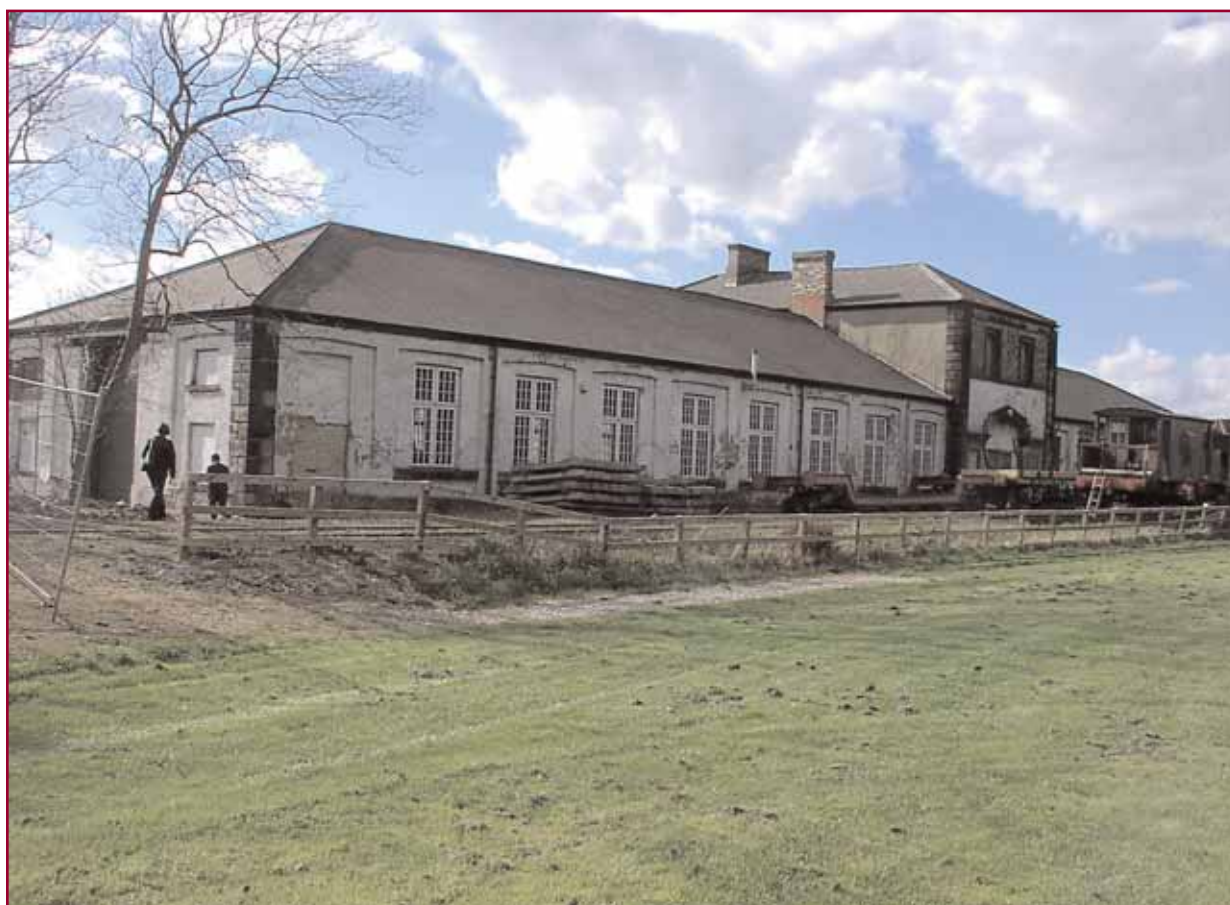
Hopetown Carriage Works, Hopetown Road Darlington

Currently in use by preservation trusts for the manufacture and restoration of steam engines, the building would benefit from a programme of regular maintenance.

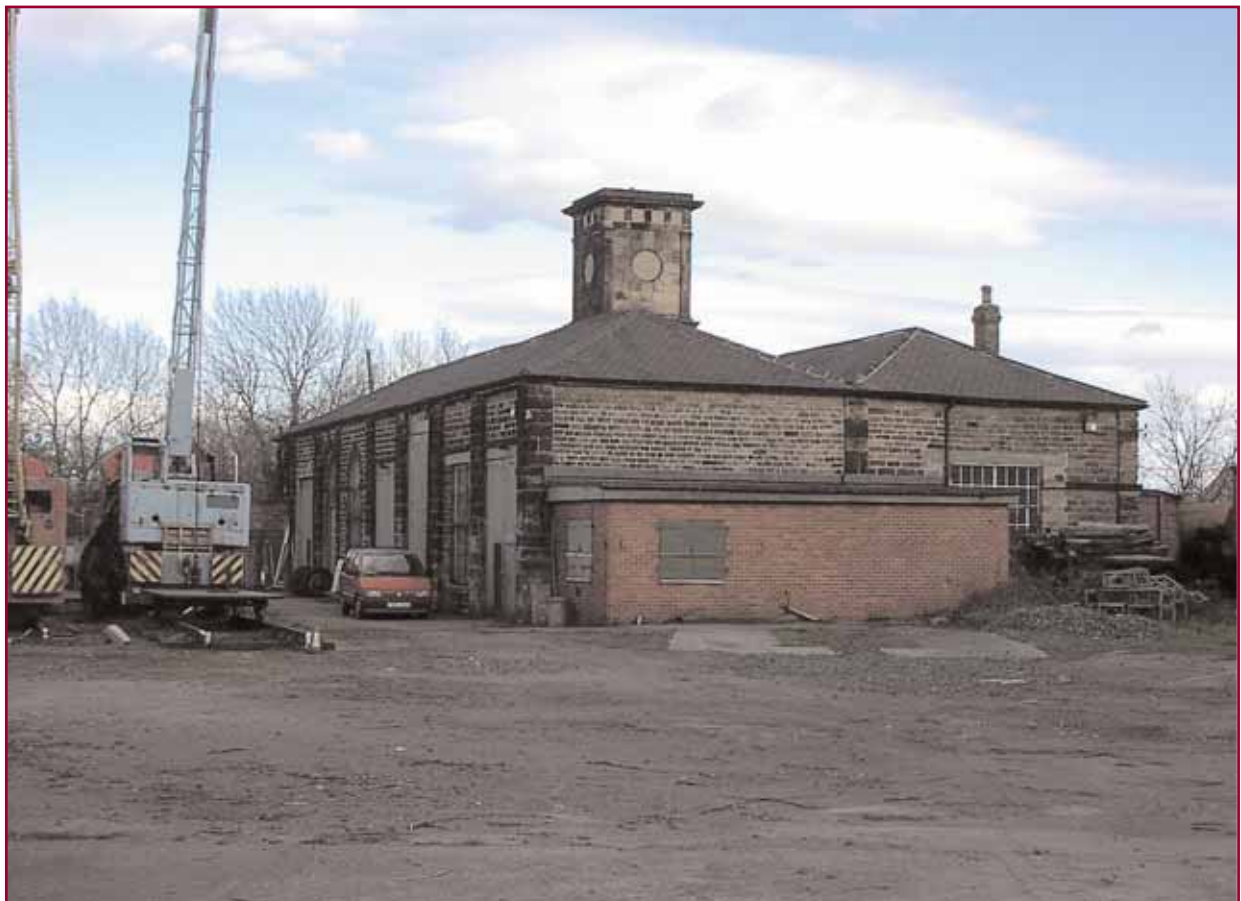
Former Goods Shed Station Road, Darlington

Now occupied by a railway preservation trust, this building could benefit from some maintenance, especially to windows and slate roof.

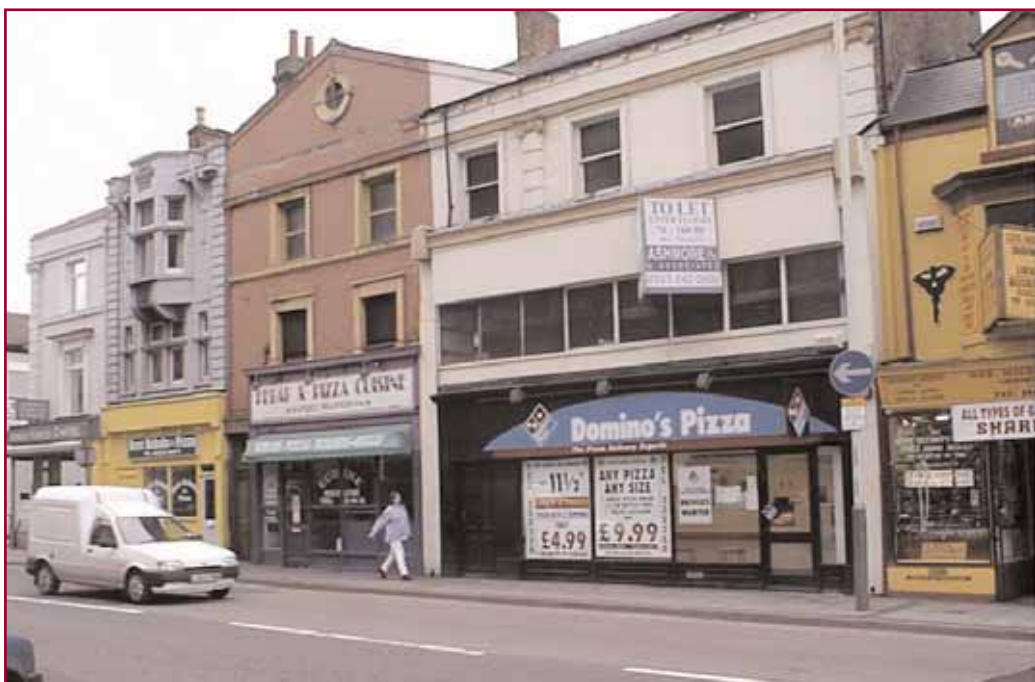
138-148 Northgate Darlington

Having suffered recent deterioration and with many upper floor areas vacant, this property suffers water ingress and general lack of maintenance. A scheme is proposed for the restoration of part of the building with the assistance of a current grant scheme.

The building would benefit from a reinstatement of the original frontage to its former late Georgian-Early Victorian appearance.

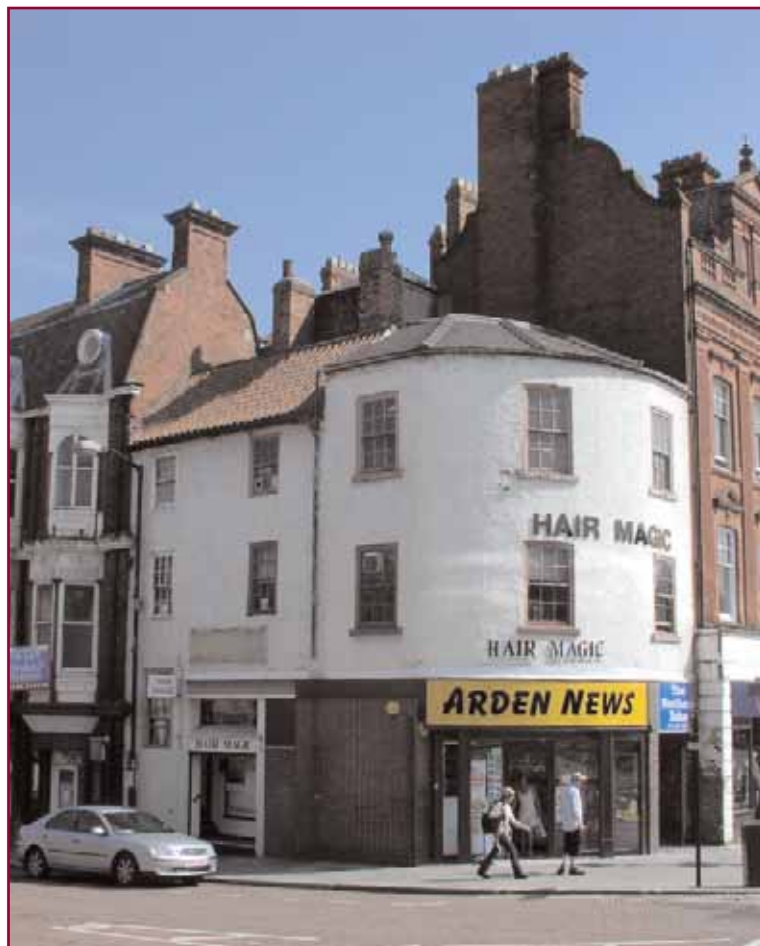
35 Tubwell Row Darlington

Although occupied, the upper floor windows are in need of some restoration.

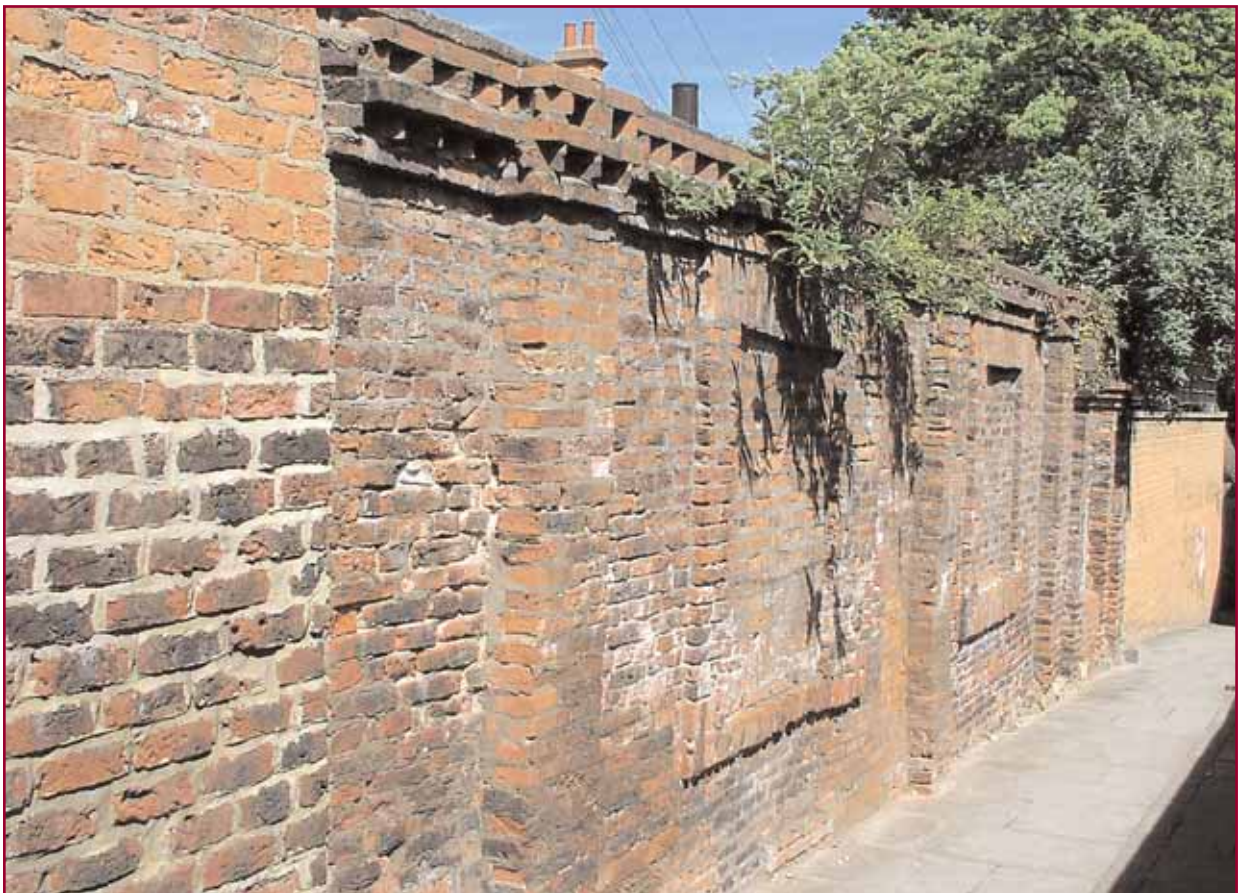
Rear boundary wall to Nag's Head Tubwell Row, Darlington

This wall has suffered poor pointing in a hard cement mortar mix, with plant growth, new, poorly choiced brick replacements and is sited in a little used alley to the rear of Tubwell Row.

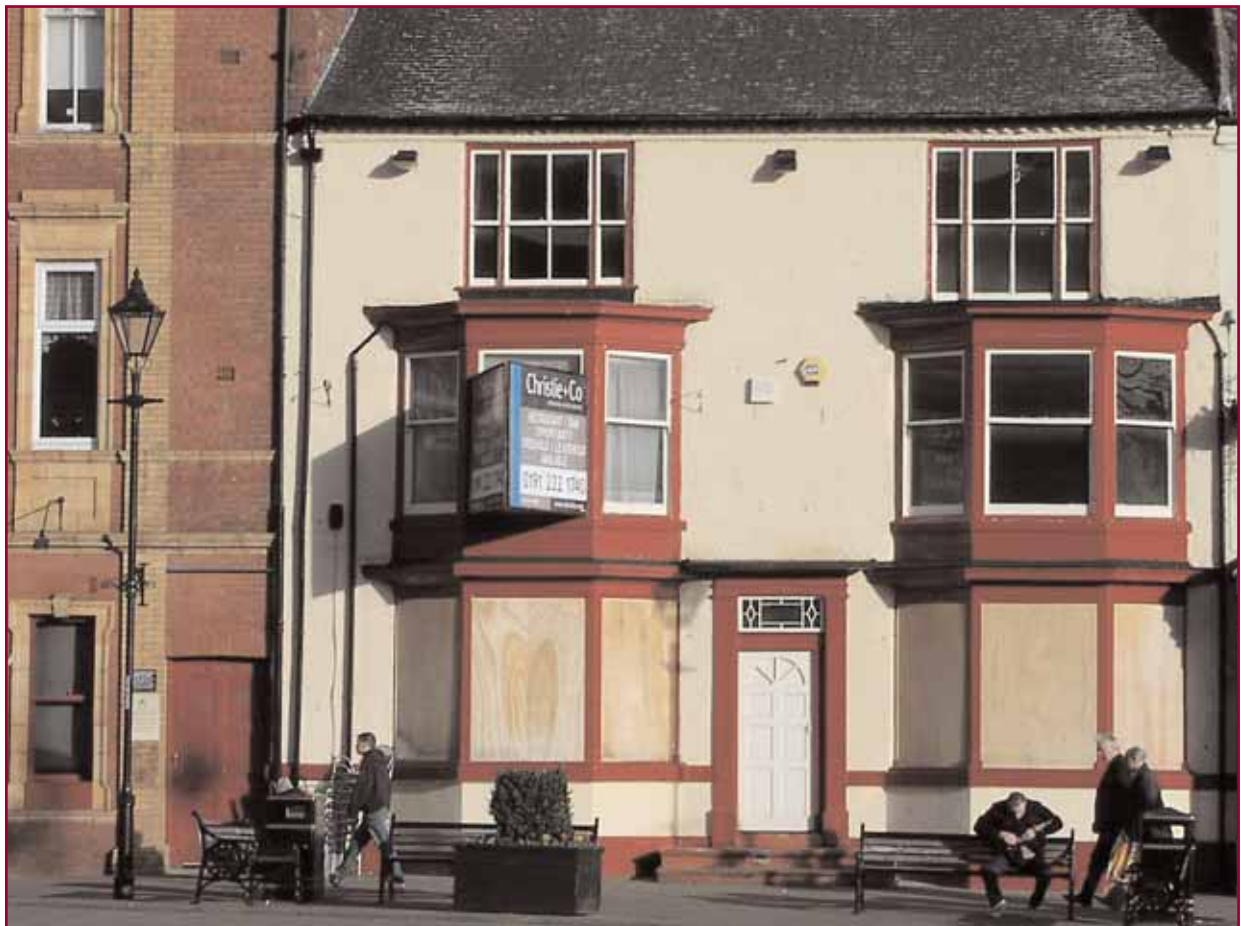
6 Bakehouse Hill Darlington

This attractive late 18th/early 19thC property has been empty for over a year and has become vulnerable to the slow process of decay and potential vandalism. Although the ground floor windows are currently boarded over, problems may be arising from decay of internal fabric. The property has recently been sold and a restoration scheme and new use is expected shortly.

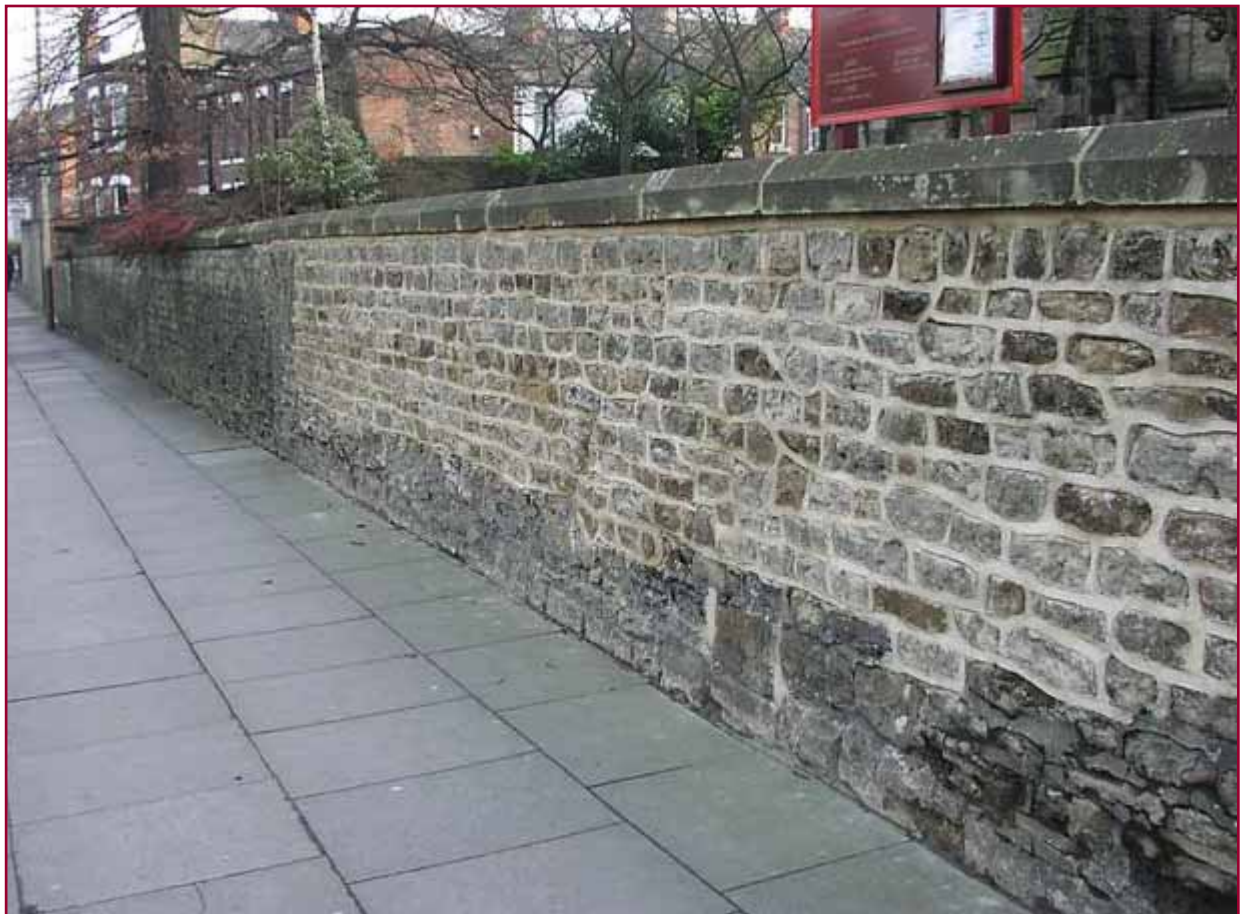
Wall at Woodland Road Darlington

Walls to Holy Trinity church. Semi-coursed sandstone rubble, with capstones, c.1836. Central pair of gate piers, tall capstones mimic the design of the church tower. Recently rebuilt using hard cement mortar and unsympathetic strap pointing. The long term result is likely to be spalling and cracking of the stone face of the wall and faster erosion of the soft stone. Repointing the outer face in lime mortar, slightly rebated back from the face, is likely to improve the wall's longevity"

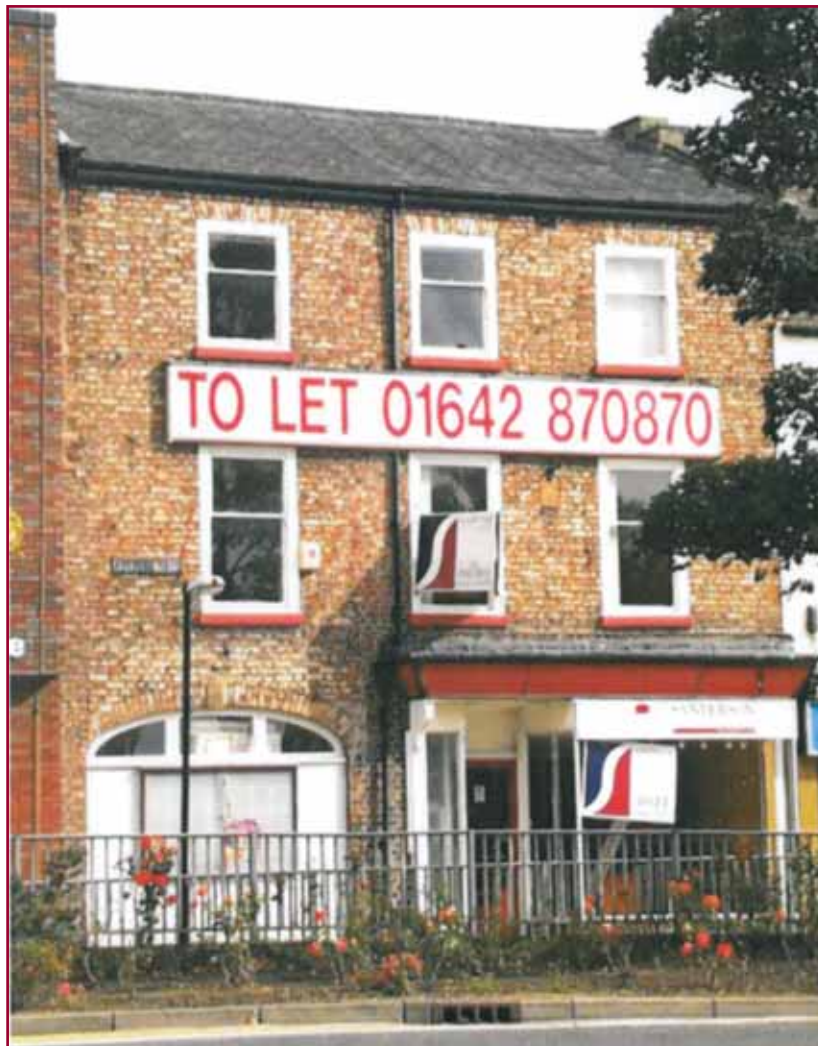
92 Bondgate Darlington

Late 18thC house, of three storeys. Pinkish brick, with fairly low pitched slate roof. Blocked cart entrance to Potter's Yard on left. Long 18thC rear wing comprising no's 1 and 15 Potter's Yard. Vacant for a number of years and currently advertised as 'To let'. The building is suffering from water ingress problems and a general delapidation."
