Darlington Borough Council

BUILDINGS AT RISK REGISTER February 2008

'BUILDINGS AT RISK' REGISTER 2008

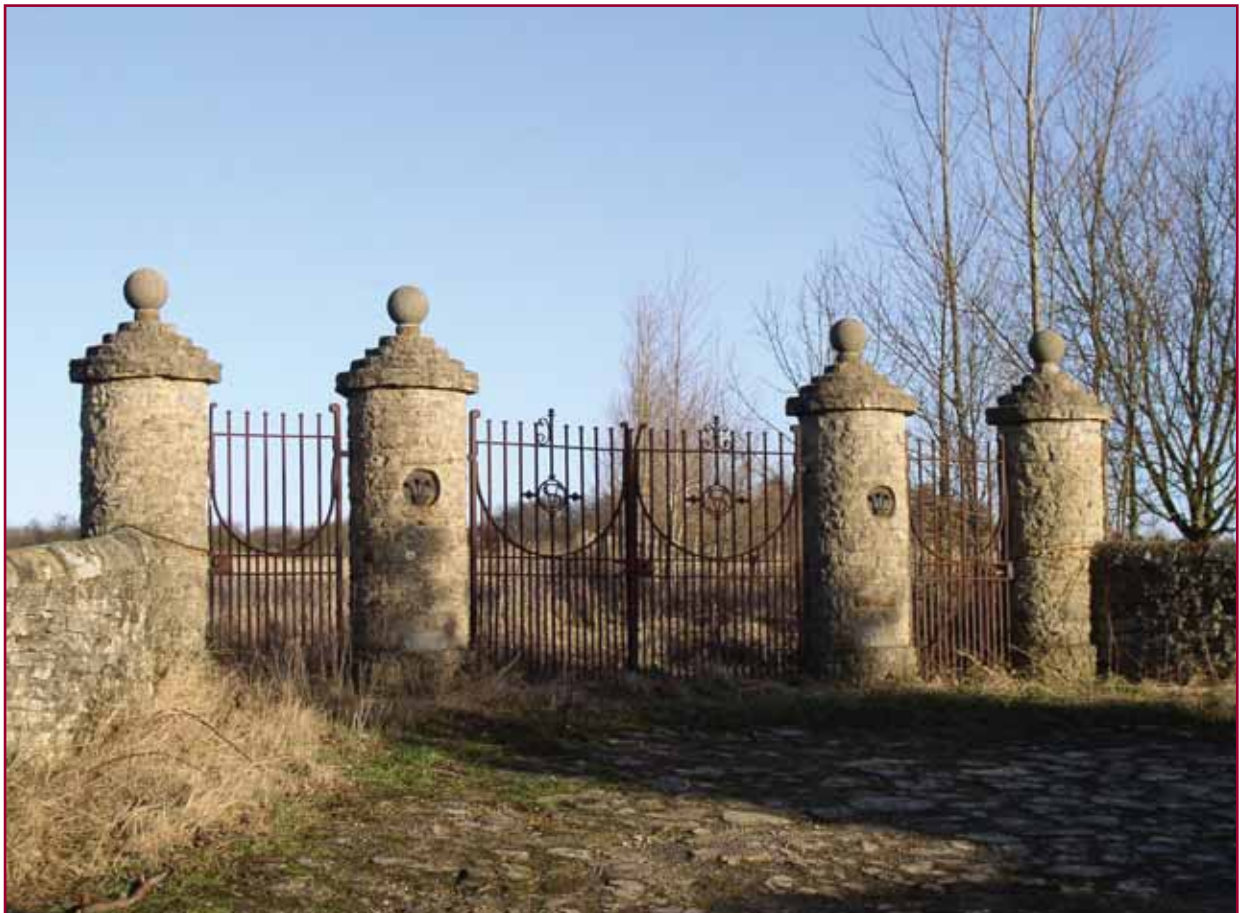
Gate and Piers at Redworth Hall Heighington

Four rusticated sandstone gate piers and wrought iron gates to Redworth Hall. Earl 19thC for Robert Surtees. Relocated to this entrance in 1923, but only used until 1939, when a new entrance was reated to the north. Surtees crest of three feathers in cast iron set within two outer piers. This entrance is no longer used, and the gates appea to have no current purpose. Although the piers and gates are in a reasonable condition, the gates require some maintenance to remove the build-up of rust.
