**DUKE STREET/LARCHFIELD STREET**

**ROAD SAFETY ASSESSMENT REPORT**

<b>Date</b>	<b>27.03.19</b>		
	<b>Prepared by</b>	<b>Checked by</b>	<b>Approved by</b>
<b>Name</b>	<b>Anthony Wilton</b>	<b>John Angus</b>	<b>Joanne Roberts</b>
<b>Signature</b>

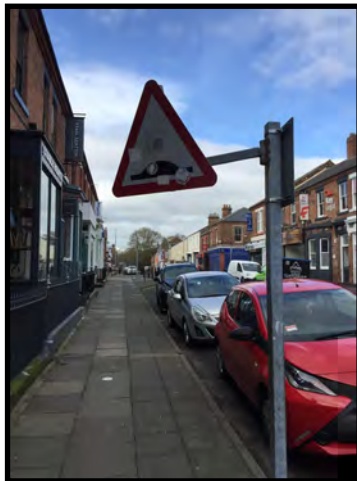
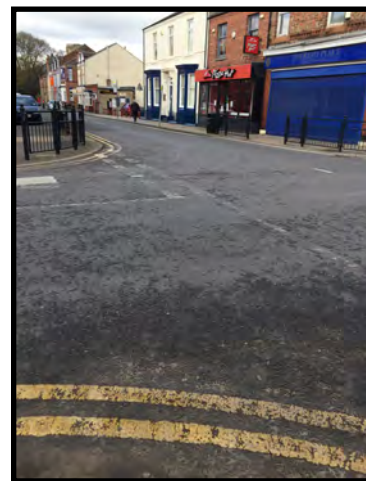
The hump warning sign on Duke Street (westbound) appears to have lost its reflectivity and is incorrectly aligned. Both the hump warning signs on Duke Street may be obstructed by either a bus or parked vehicle in the parking bay on the eastbound and westbound approaches respectively. This could lead to the warning signs being missed and may result in higher approach speed at the junction.

The give way signs on both approaches are lit and in good working order. The give way road marking on Larchfield Street (northbound) have become partially worn. This could lead to drivers failing to give way at the junction; two of the road collisions on this approach, involved drivers failing to give way at the junction.

- 4.1 Introduction of “no loading at any time” restrictions on the north side of Duke Street at the junction of Larchfield Street to ensure minimum inter-visibility of 43m (Manual for Streets) is maintained between road users on major and minor arms of the junction.
- 4.2 Extension of the guard rail on the north side of Duke Street to reinforce the “no loading at any time” restrictions.
- 4.3 Provide adequate opportunities on the north side of Duke Street to allow two way traffic to pass after 6pm and vehicles can legally park on the north side of Duke Street.
- 4.4 Refresh the road markings at the junction and provide yellow backing boards for the “give way” signage on both Larchfield Street approaches.
- 4.5 Provide additional traffic calming measure on both Larchfield Street approaches to reinforce the table top junction.

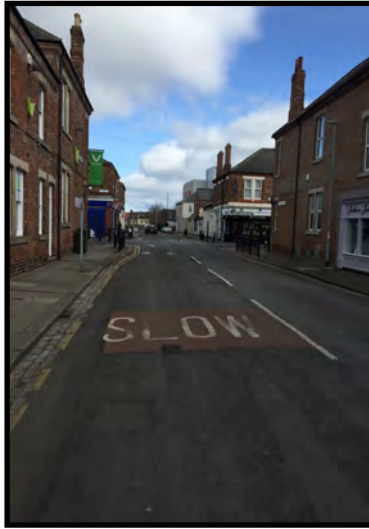
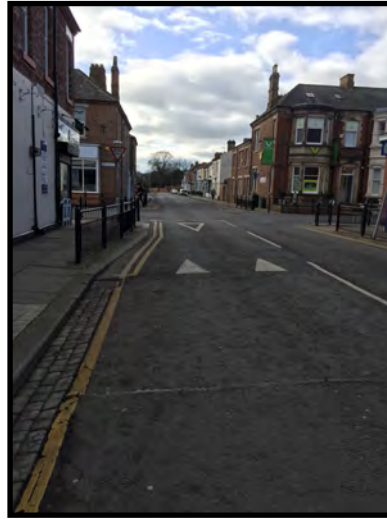
The junction is currently raised. However the gradient of the ramps to the table top on all approaches are gentle due to the carriageway levels.

The approaches on Larchfield Street are relatively straight, which can lead to higher vehicle speeds, and the gentle ramps of the table top are unlikely to significantly reduce vehicle approach speeds.

This may lead to drivers failing to give way at the junction, three of the collisions involved drivers failing to stop at the give way and one collision was the result of the second vehicle in the queue failing to stop and caused a shunt type collision.
