DARLINGTON BOROUGH COUNCIL SCHEDULED MONUMENTS AUDIT 2009

Undertaken between March and June 2009

Written, photographed and surveyed by Timothy Crawshaw and Heather Grimshaw, Darlington Brough Council.

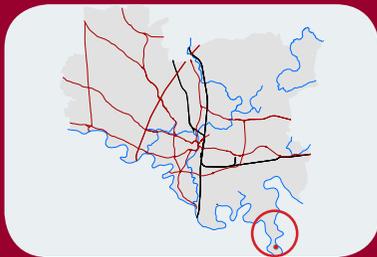
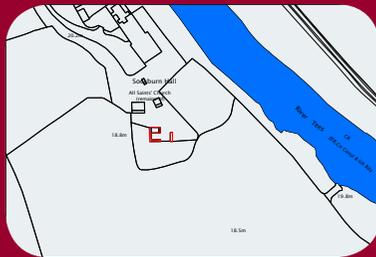
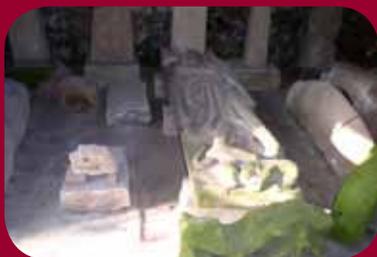
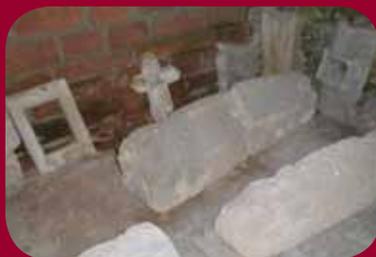
Sockburn Church (All Saints')

The remains of the church are part of a much wider heritage landscape comprising of Sockburn Hall and various other historical features. Having suffered from the encroachment of vegetation over the years the evidence of this can be seen in the structure and on the ground.

Thanks to the efforts of the owner and volunteers the church is no longer under serious threat from vegetation although it remains in a precarious state.

The church is in poor condition although recent efforts have removed any immediate threat to its survival.

Greater public access would be desirable as the church contains, in the Conyers Chapel, an important collection of pre-Conquest artefacts that would be of interest to both expert and lay person. If this were facilitated more interpretative materials would be valuable.

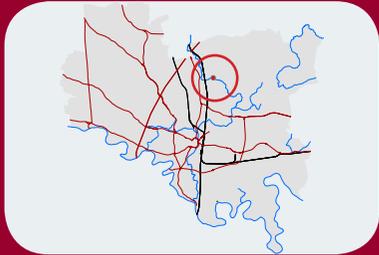
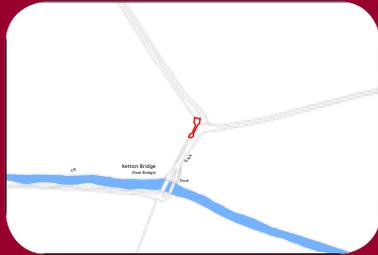
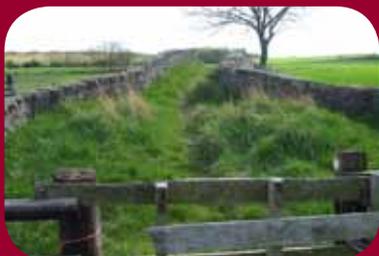
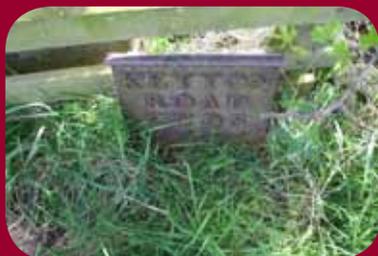
NMR Name:
Ketton Bridge
Local Name:
 N/A

CONDITION:
 The site appears to be in a stable condition with no immediate or urgent threats, although it has been hit by a vehicle.

POTENTIAL IMPROVEMENTS:
 Some interpretation materials would assist in understanding the bridge and its location as well as its historic strategic transport importance.

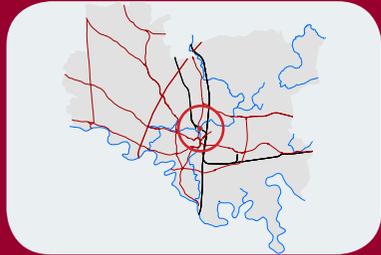
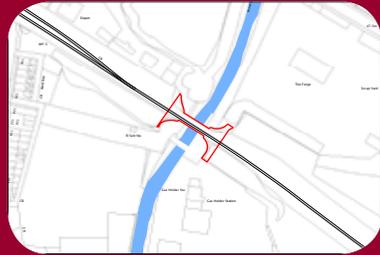
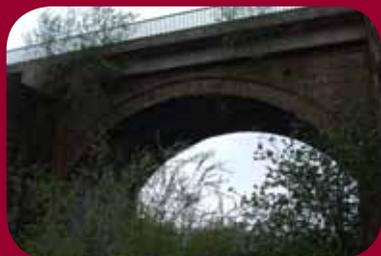
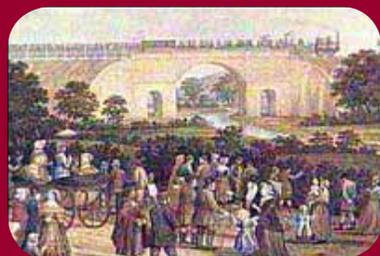
NMR Name:
Skerne Bridge
Local Name:
 £5 Note Bridge

SITE OBSERVATIONS:
 The immediate vicinity of the bridge is of a poor quality and is cut off from the main pedestrian routes. As the bridge has a blocked arch access through is limited and the bridge lies at a dead end. Historically important both locally and nationally this monument has suffered vandalism and unsympathetic additions over the years.

CONDITION:
 The site appears to be in a stable condition, however vegetation may be threat in the long term.

POTENTIAL IMPROVEMENTS:
 Opening up the pedestrian arch would improve access and natural surveillance of the monument, at present there is no need to pass close to the bridge. Interpretative materials would help to highlight the importance of this monument.

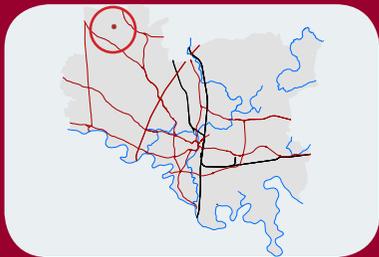
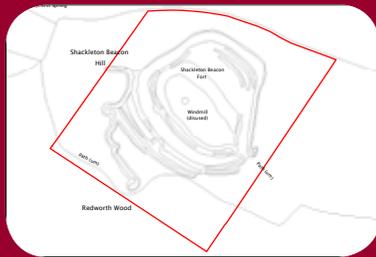
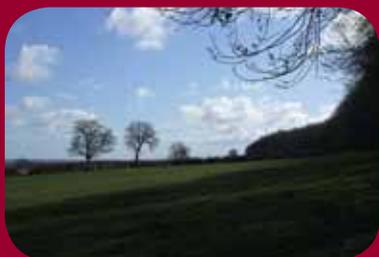
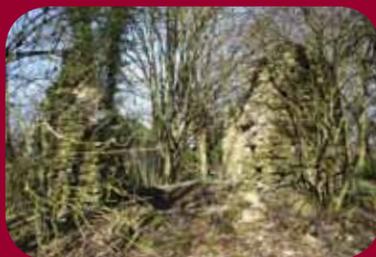
Shackleton Beacon Hill

Much of the site is inaccessible, overgrown and fenced off.

The site continues to be under threat from scrub and tree growth.

Greater access would be welcome as this is a prominent feature in the landscape and would afford great views. This access could be made from the adjoining public footpath.

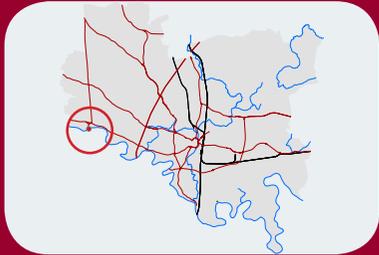
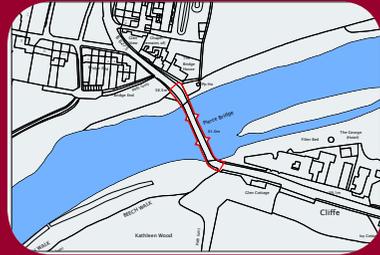
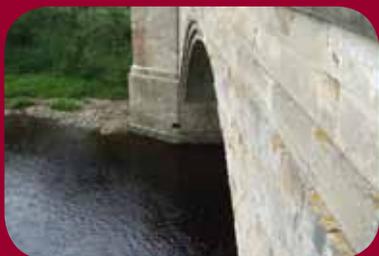
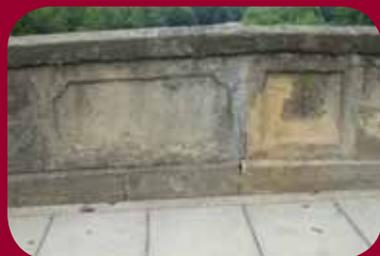
NMR Name:
Piercebridge Bridge
Local Name:
 DA55 **Medium Risk** NZ21071556

CONDITION:
 The bridge has suffered damage at river level and subsequent cracking. English Heritage have also identified vehicle damage as a risk.
 ★★☆☆☆

POTENTIAL IMPROVEMENTS:
 Some interpretative material would be a useful addition, especially as the bridge is still in use for traffic and pedestrians.

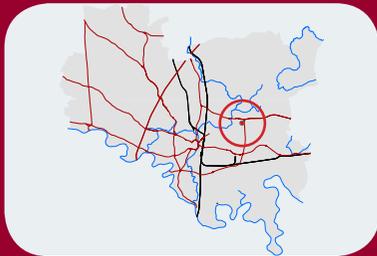
The site appears to be in a stable condition. Some damage to the brickwork is in evidence.
