Darlington Borough Council

BUILDINGS AT RISK REGISTER February 2008

'BUILDINGS AT RISK' REGISTER 2008

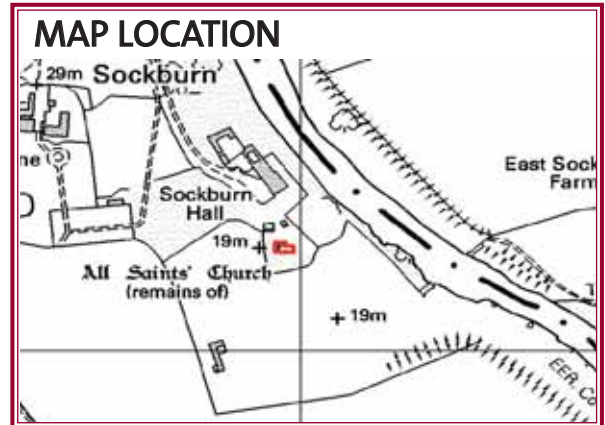
All Saints Church

Ruined church. Pre-Norman nave and chancel; late 12thC south aisle; the chancel was rebuilt in the early 13thC; 14thC chantry, now the Conyers chapel; the latter was restored and re-roofed in 1900 by WH Knowles; chancel roofless.

Funding has recently been offered by the Church Commissioners for Durham diocese and English Heritage, for the replacement of the roof, which would greatly assist in consolidating this important mediaeval building.

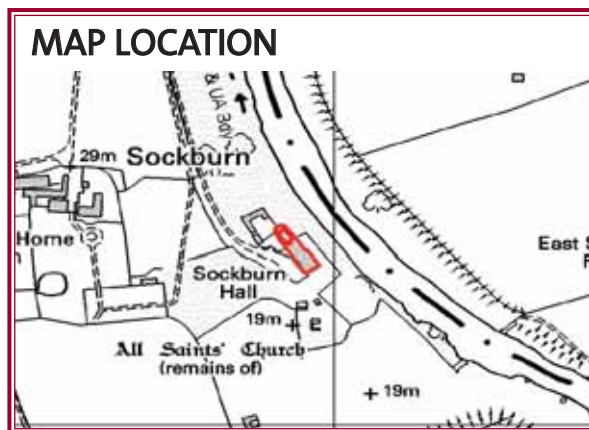
Sockburn Hall

This property has been vacant for several years and suffered a collapse of a number of roof and floor timbers due to water penetration. The owners are now looking to retain the building.

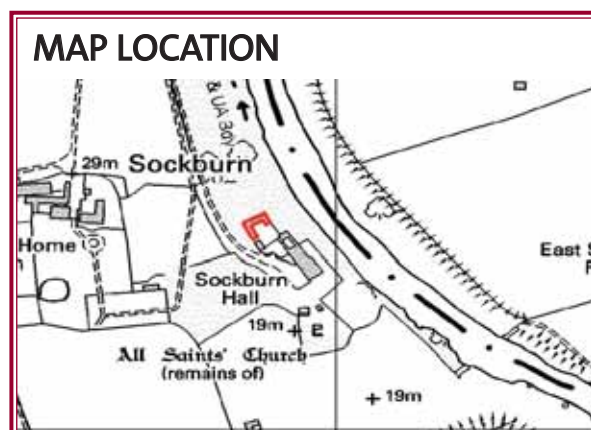
Former Coach House to Sockburn Hall

Currently vacant, dilapidated, missing roof tiles and with serious water ingress, the building in association with Sockburn Hall is being retained by the owners.

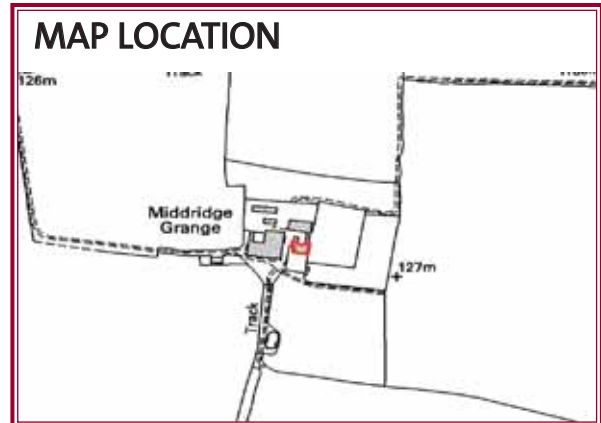
Sildon Lane, Heighington

Large farmhouse c.1600, with alterations and additions from around 1690, 1720, 1850 and 1897. Partly rendered coursed sandstone rubble; Welsh slate and clay pantile roofs, the latter with stone-flagged eaves. Currently vacant and identified as being at risk since 1997, English Heritage has recently provided grant aid towards the preparation of a condition survey and outline repair proposals.

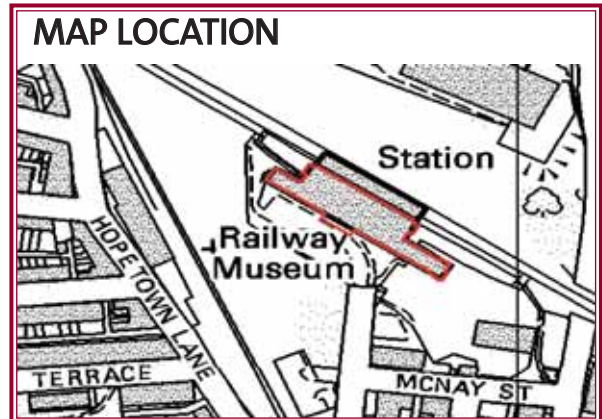
Station Road, Darlington

Railway Station, opened in 1842, with later amendments/additions. Served the original Stockton & Darlington Railway. Now used as a Museum as well as a public station. Poor maintenance resulted in serious structural decay of the roof trusses. Following an English Heritage-funded conservation plan, a repair solution was agreed and a major EH grant offered in April 2006 towards re-roofing the station. The building is due to open to visitors following a refurbishment programme, in April 2007.

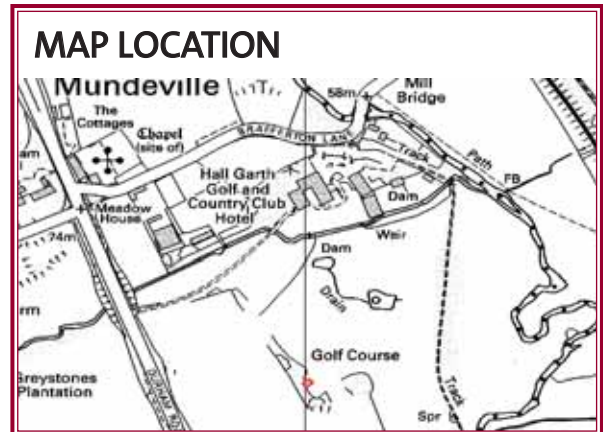
Although having recently been re-roofed, some serious structural cracks are visible in the right hand elevation wall.

Discussions have recently taken place between the Conservation Officer and new owners, and measures to repair structural cracks caused by subsidence have been agreed.

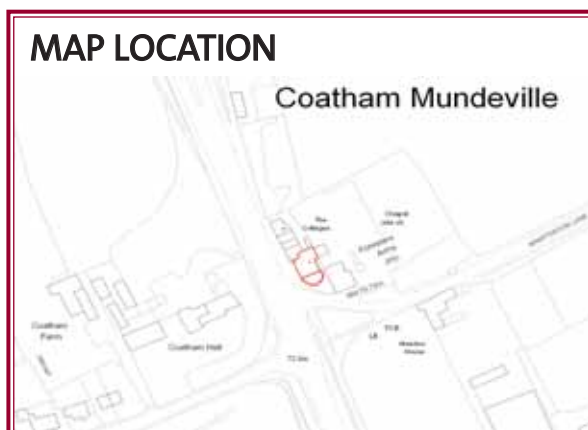
Glebe Farmhouse, Coatham Mundeville

Currently in need of significant maintenance, with wooden lintels above some windows failing; serious loss of mortar pointing in a number of areas, and right hand external chimney-stack suffering from serious stonework erosion.

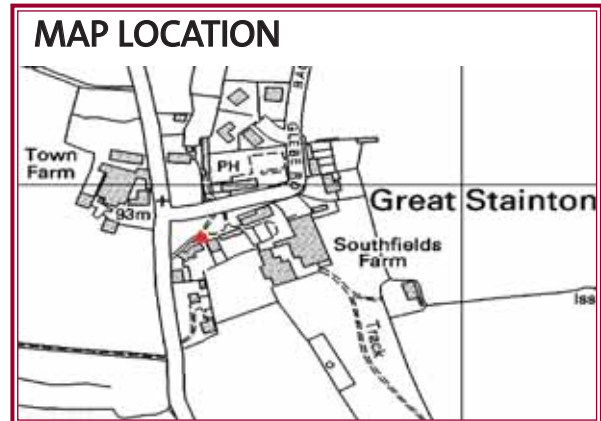
Water Pump & Railing The Green, Great Stainton

Built to commemorate the Golden Jubilee of Queen Victoria in 1887, this ornamental water pump with its surrounding cast and wrought iron railings is steadily deteriorating. The wooden case in which the pump is housed is rotting badly in places, and in need of some replacement boards. The steel plaque, which highlights the event, has cracked in two and has erosion of the raised lettering.

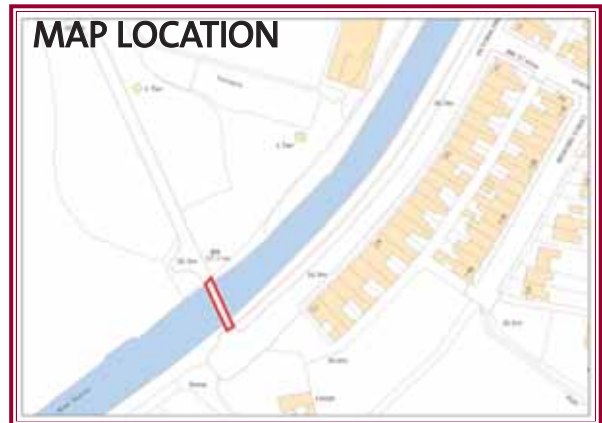
Polam Lane Bridg Darlington

Footbridge spanning River Skerne, built c.1891 of cast and wrought iron. North and South sandstone abutments. Built in association with South Park, the elaborate wrought iron ornamental handrails are themselves an attractive feature. The steel beams supporting the footpath are corroded and in need of replacement."

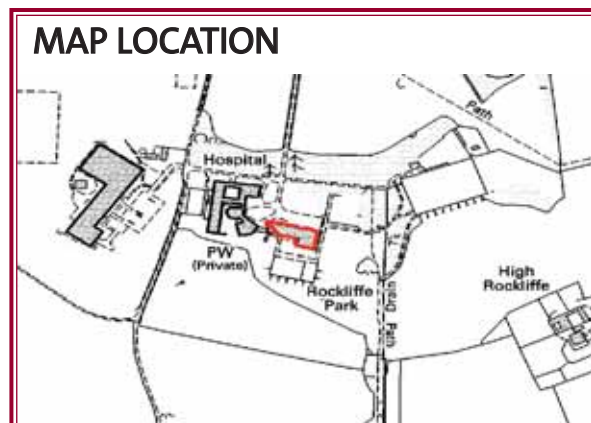
St. Cuthbert's Hospital in Rockcliffe Park Hurworth Road, Hurworth

This building suffers from water ingress caused through roof tile slippage, with resultant damaged ceilings/floors, with some vandalism and a general lack of maintenance. A new scheme of enabling development, allowing the building to be restored and re-used as a hotel, is going through the planning system, with minor changes to the listed building.

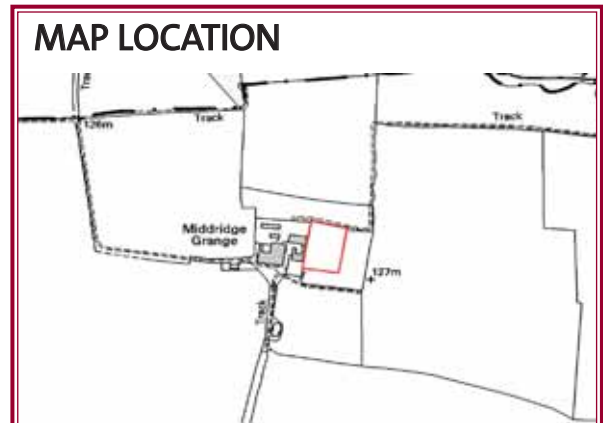
Garden wall and pair of gate piers, 2.5-3 metres tall, broken down and partly rebuilt in places; probably late 17th-Early 18thC. Coursed rubble walls with ashlar piers; walls enclose an L-shaped area known as The Bull Park.

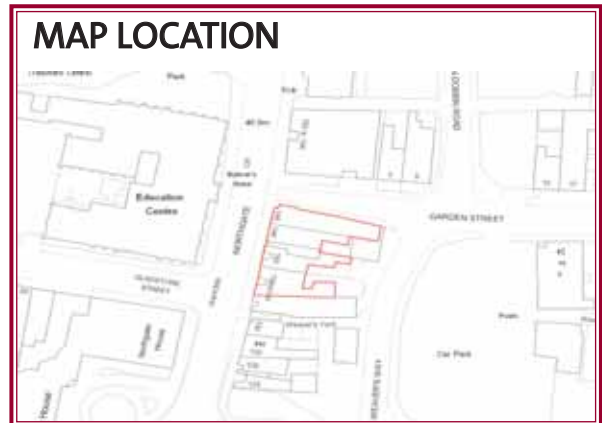
138-148 Northgate Darlington

Having suffered recent deterioration and with many upper floor areas vacant, this property suffers water ingress and general lack of maintenance. A scheme is proposed for the restoration of part of the building with the assistance of a current grant scheme.

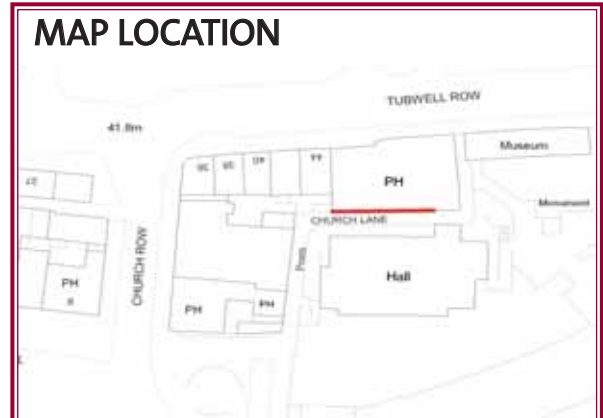
This wall has suffered poor pointing in a hard cement mortar mix, with plant growth, new, poorly choiced brick replacements and is sited in a little used alley to the rear of Tubwell Row.

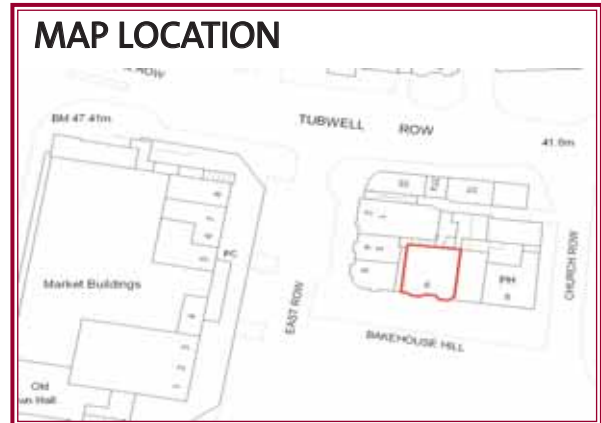
This attractive late 18th/early 19thC property has been empty for over a year and has become vulnerable to the slow process of decay and potential vandalism. Although the ground floor windows are currently boarded over, problems may be arising from decay of internal fabric. The property has recently been sold and a restoration scheme and new use is expected shortly.

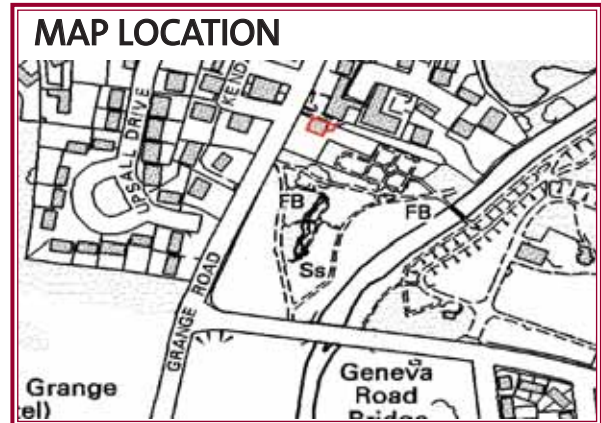
Neasham House is a late 18th or Early 19th century house of two storeys and three bays. Empty for a number of years, the house would benefit from a programme of sensitive maintenance. Situated beside the recently restored South Park, the house would make an ideal family home. The building has recently been sold and a scheme for its full restoration is on-going.

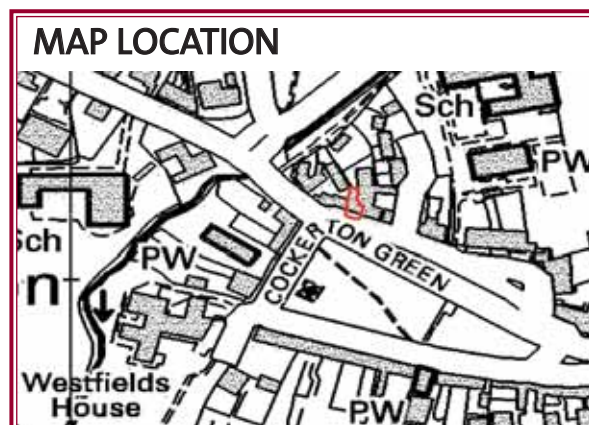
82 Cockerton Green Darlington

A late 18thC cottage, of two bays, with sash windows, rough rendered walls and two mid 19thC canted bays, and Victorian four-panelled door. Currently used as the local scout group headquarters, the building requires a programme of maintenance to repaint/restore the door and windows and some render repairs. As this building is no in domestic use, it is likely that some internal repairs and maintenance are required in order to conserve the building's historic fabric. The bays and windows have been replaced.

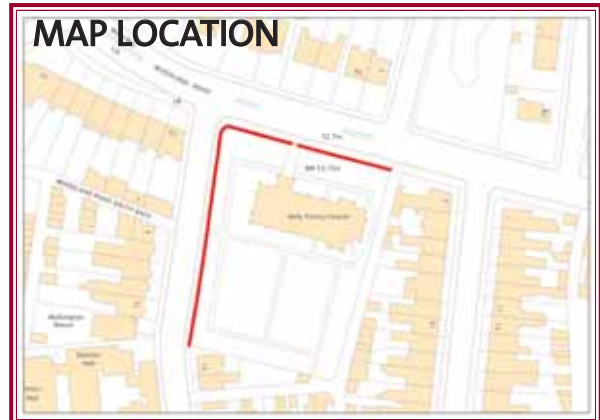
Wall at Woodland Road Darlington

Walls to Holy Trinity church. Semi-coursed sandstone rubble, with capstones, c.1836. Central pair of gate piers, tall capstones mimic the design of the church tower. Recently rebuilt using hard cement mortar and unsympathetic strap pointing. The long term result is likely to be spalling and cracking of the stone face of the wall and faster erosion of the soft stone. Repointing the outer face in lime mortar, slightly rebated back from the face, is likely to improve the wall's longevity"

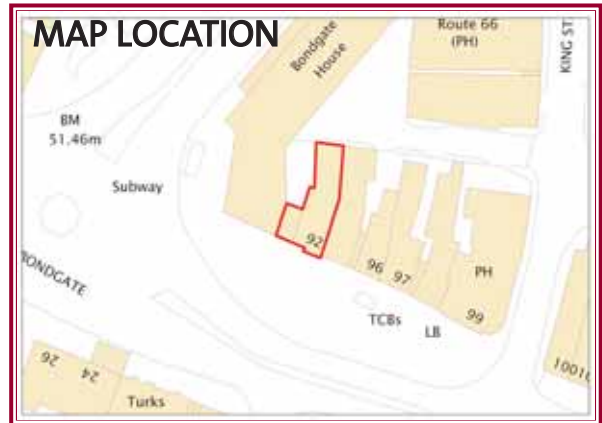
Late 18thC house, of three storeys. Pinkish brick, with fairly low pitched slate roof. Blocked cart entrance to Potter's Yard on left. Long 18thC rear wing comprising no's 1 and 15 Potter's Yard. Vacant for a number of years and currently advertised as 'To let'. The building is suffering from water ingress problems and a general delapidation."

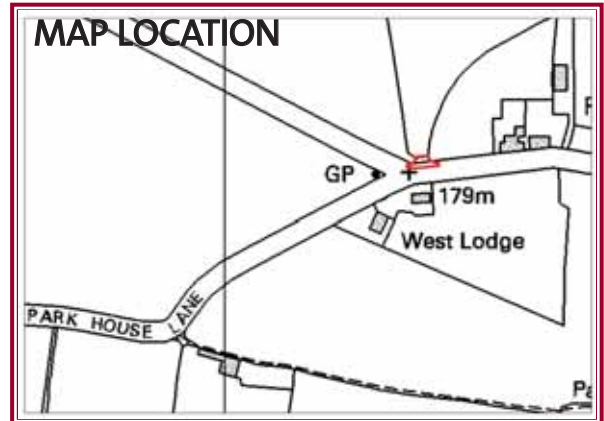
Gate and Piers at Redworth Hall Heighington

Four rusticated sandstone gate piers and wrought iron gates to Redworth Hall. Earl 19thC for Robert Surtees. Relocated to this entrance in 1923, but only used until 1939, when a new entrance was reated to the north. Surtees crest of three feathers in cast iron set within two outer piers. This entrance is no longer used, and the gates appea to have no current purpose. Although the piers and gates are in a reasonable condition, the gates require some maintenance to remove the build-up of rust.

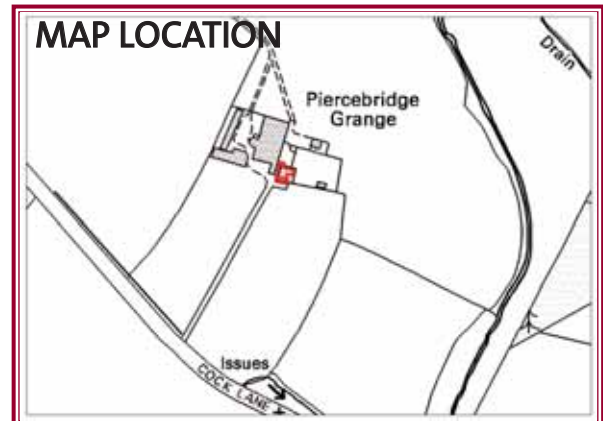
Piercebridge Grange Farm Piercebridge, Nr Darlington

Farmhouse, front garden wall, iron railings and gate. Mid 18thC with 19thC alterations and wing. Roughcast render over rubble stone, with clay pantile and slate roofs. Empty for a number of years, and suffering from a process of slow decay. The property is currently for sale, with the adjacent related agricultural buildings having been recently converted to residential use.
