DARLINGTON BOROUGH COUNCIL SCHEDULED MONUMENTS AUDIT 2009

Undertaken between March and June 2009

Written, photographed and surveyed by Timothy Crawshaw and Heather Grimshaw, Darlington Brough Council.

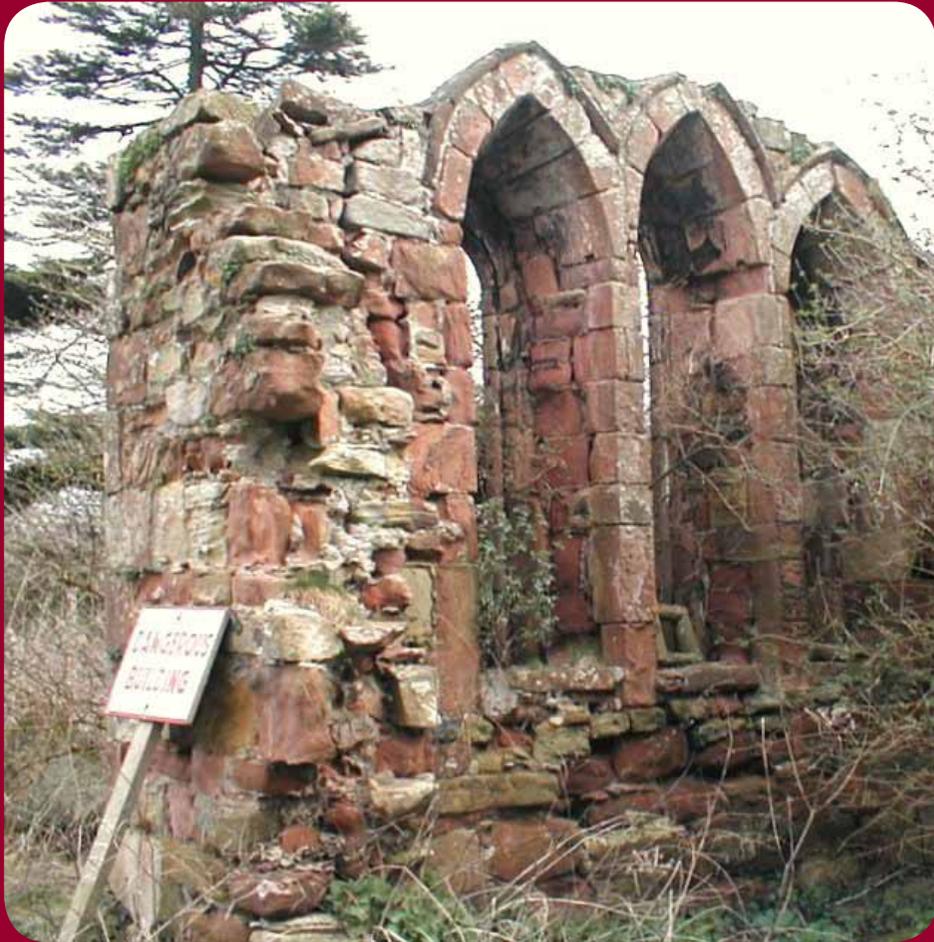
Sockburn Church (All Saints')

The remains of the church are part of a much wider heritage landscape comprising of Sockburn Hall and various other historical features. Having suffered from the encroachment of vegetation over the years the evidence of this can be seen in the structure and on the ground.

Thanks to the efforts of the owner and volunteers the church is no longer under serious threat from vegetation although it remains in a precarious state.

The church is in poor condition although recent efforts have removed any immediate threat to its survival.

Greater public access would be desirable as the church contains, in the Conyers Chapel, an important collection of pre-Conquest artefacts that would be of interest to both expert and lay person. If this were facilitated more interpretative materials would be valuable.

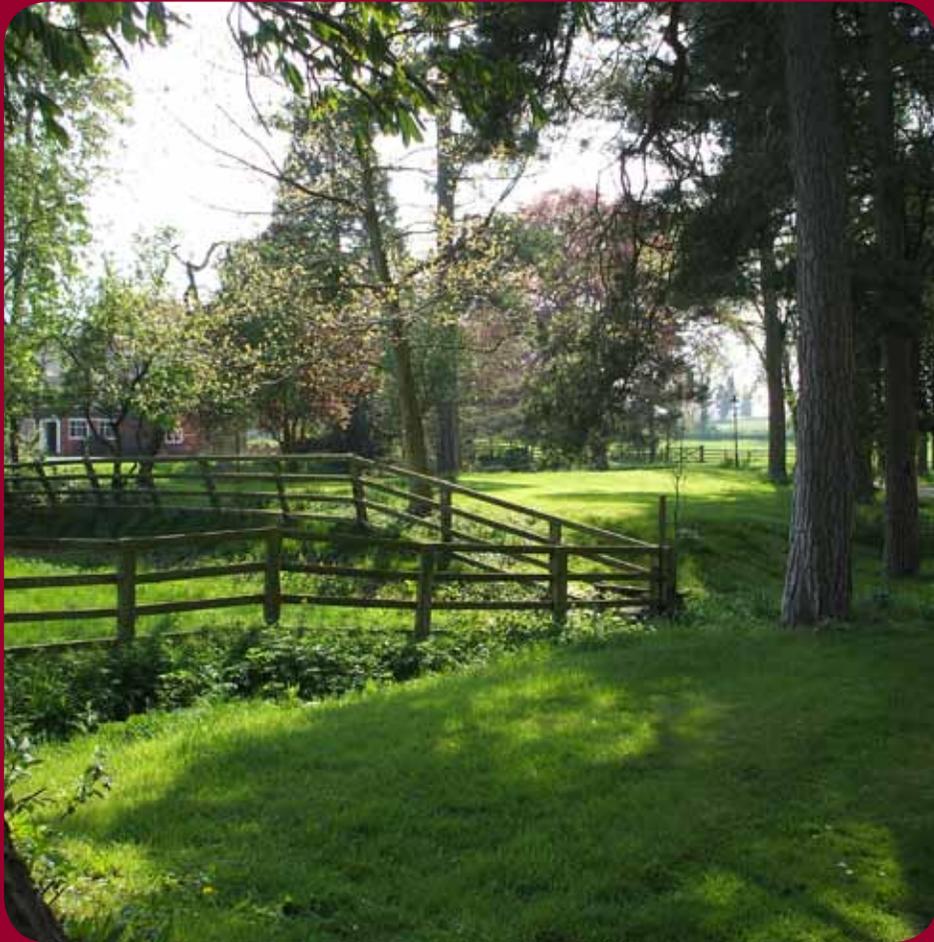
NMR Name:
Medieval moated manorial site of Low Dinsdale at the Manor House
Local Name:
 N / A
 20873 Not At Risk NZ3460 1099

SITE OBSERVATIONS:
 This extensive site surrounds the current Manor house and is partly garden and partly fields. The use of the site for grazing keeps the encroachment of scrub at bay and the area that is garden is well cared for. The owner provided a fascinating insight into the history of the site and engaging interpretation when the site was visited. School and interest groups visit the site by arrangement.

CONDITION:
 The site appears to be in a stable condition although care would need to be taken where agricultural uses continue, to prevent erosion.
 ★★★★★

POTENTIAL IMPROVEMENTS:
 As the bulk of the site is private grounds it is unlikely that public access could be secured. Some interpretation of both this site and the nearby Anglo Saxon cross in the churchyard would be a welcome addition and provide context for visitors to the village and church.

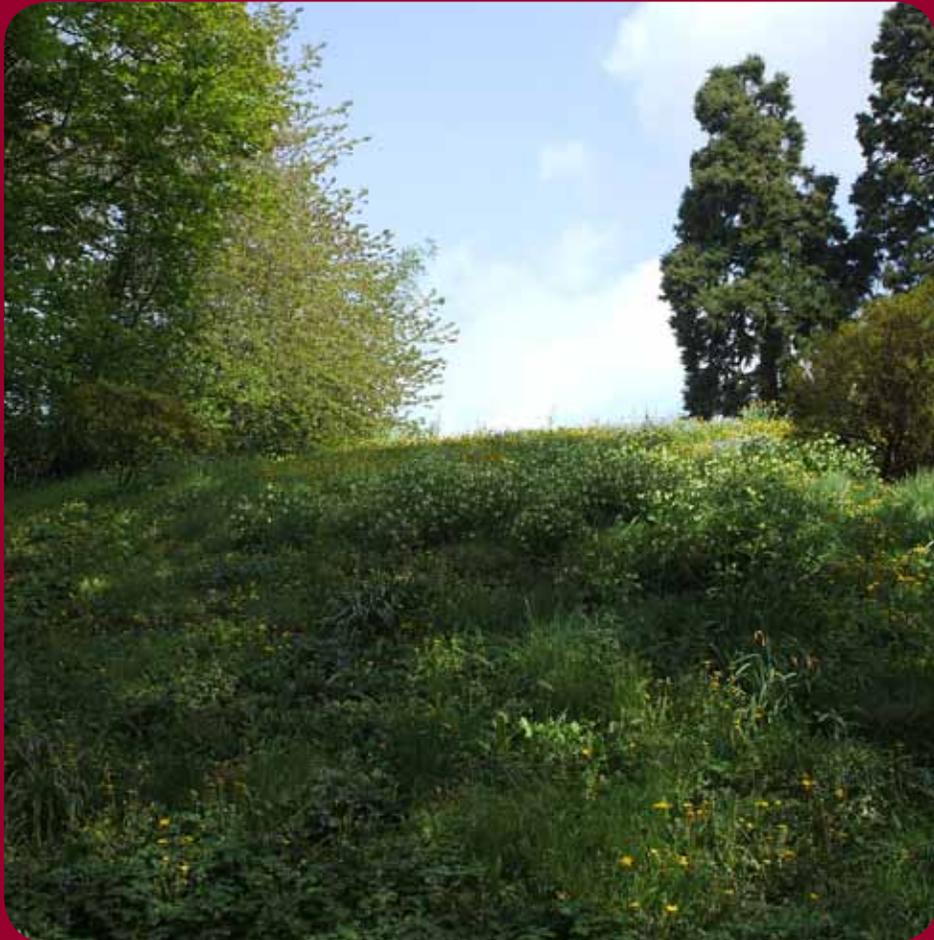
Tower Hill motte castle, 370m NE of Dinsdale Spa

The site is largely overgrown and forms a central feature for the properties around. There are a small number of steps up to the motte itself although no public access exists. There appears to be no immediate threat to the site other than invasive tree growth.

The site appears to be in a stable condition with no immediate or urgent threats.

As the site is on private land further access may be difficult to arrange. From a vantage point it may be possible to provide some interpretation. This site could be an interesting feature as part of an open gardens scheme.

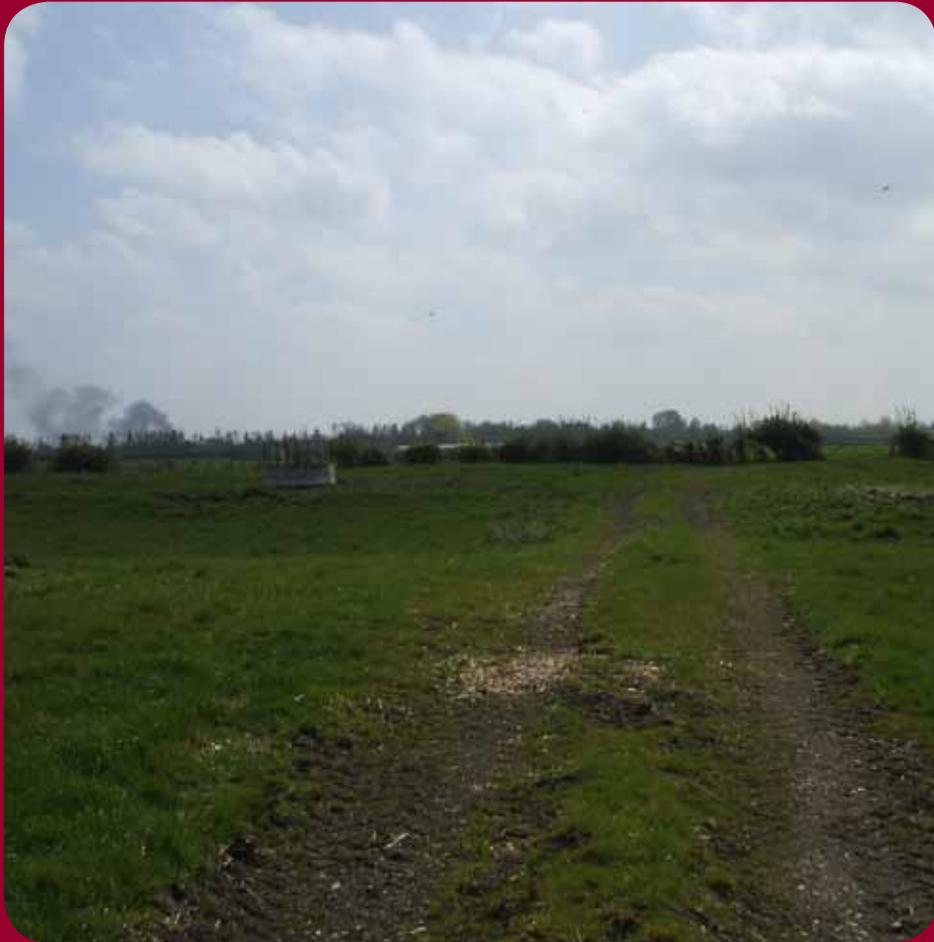
Deserted medieval village of West Hartburn, 100m north-east of Foster House

The site is given over to pasture with the remains of the village visible and identifiable on the ground. The hollow way is very visible from the road.

The site appears to be in a stable condition with no immediate or urgent threats.

At the points where the site is visible some interpretative material would be useful for passers by and visitors. As the site is on private land further access is unlikely.

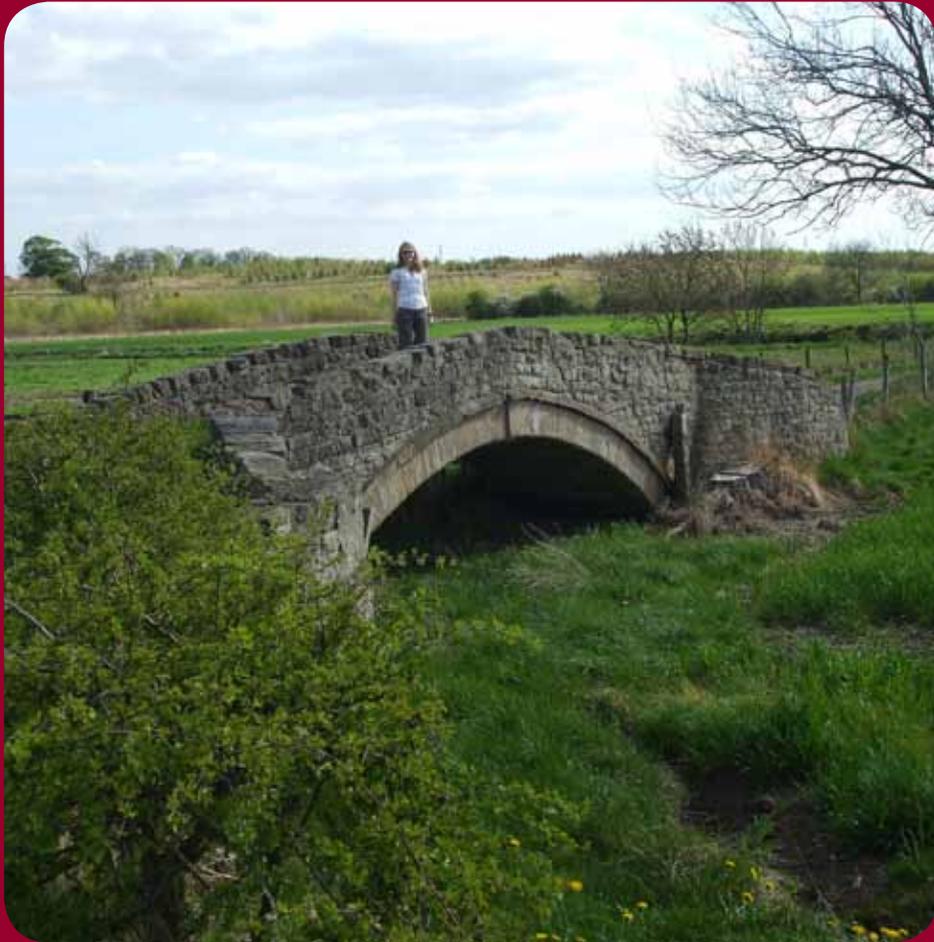
NMR Name:
Ketton Bridge
Local Name:
 N/A

SITE OBSERVATIONS:
 The bridge is only accessible from the public rights of way network as the access road is private. It is possible to walk on and over the bridge and see the diverted, course of the river.

CONDITION:
 The site appears to be in a stable condition with no immediate or urgent threats, although it has been hit by a vehicle.

POTENTIAL IMPROVEMENTS:
 Some interpretation materials would assist in understanding the bridge and its location as well as its historic strategic transport importance.

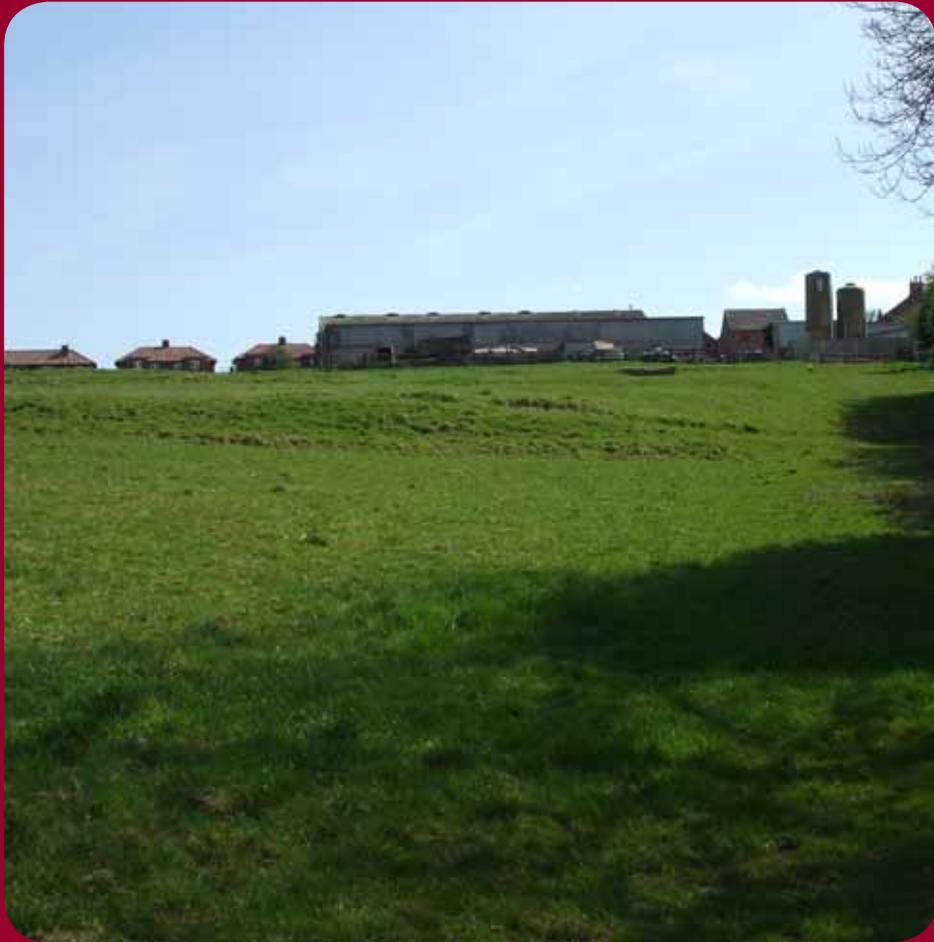
Shrunken medieval village at Sadberge

From the vantage points available the evidence on the ground is quite hard to decipher. The bulk of the sites are enclosed and do not allow direct access.

The site appears to be in a stable condition with no immediate or urgent threats.

Interpretative materials at the roadside or at the entrance to the footpath would be a useful addition. This could also be sited next to the new houses in the village that abut one of the sites.

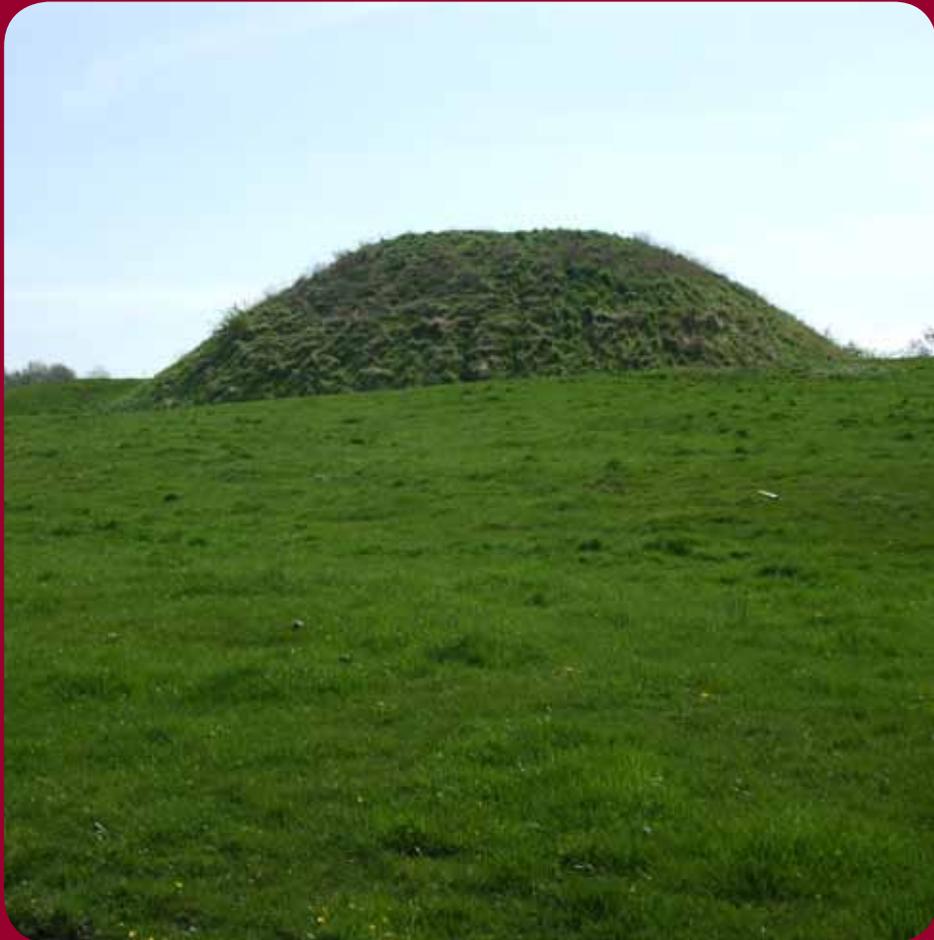
NMR Name:
Motte and bailey castle 400m south east of Bishopton
Local Name:
 N/A
 20970 Not at Risk NZ36672090

CONDITION:
 The site appears to be in a stable condition with no immediate or urgent threats.
 ★★★★★

SITE OBSERVATIONS:
 This well preserved site is easily accessible, although the motte is fenced off. The interpretation material helps in understanding the site. A footpath runs through the site.

POTENTIAL IMPROVEMENTS:
 The interpretation board is a welcome feature, although it has faded a little and some elements are incomplete.

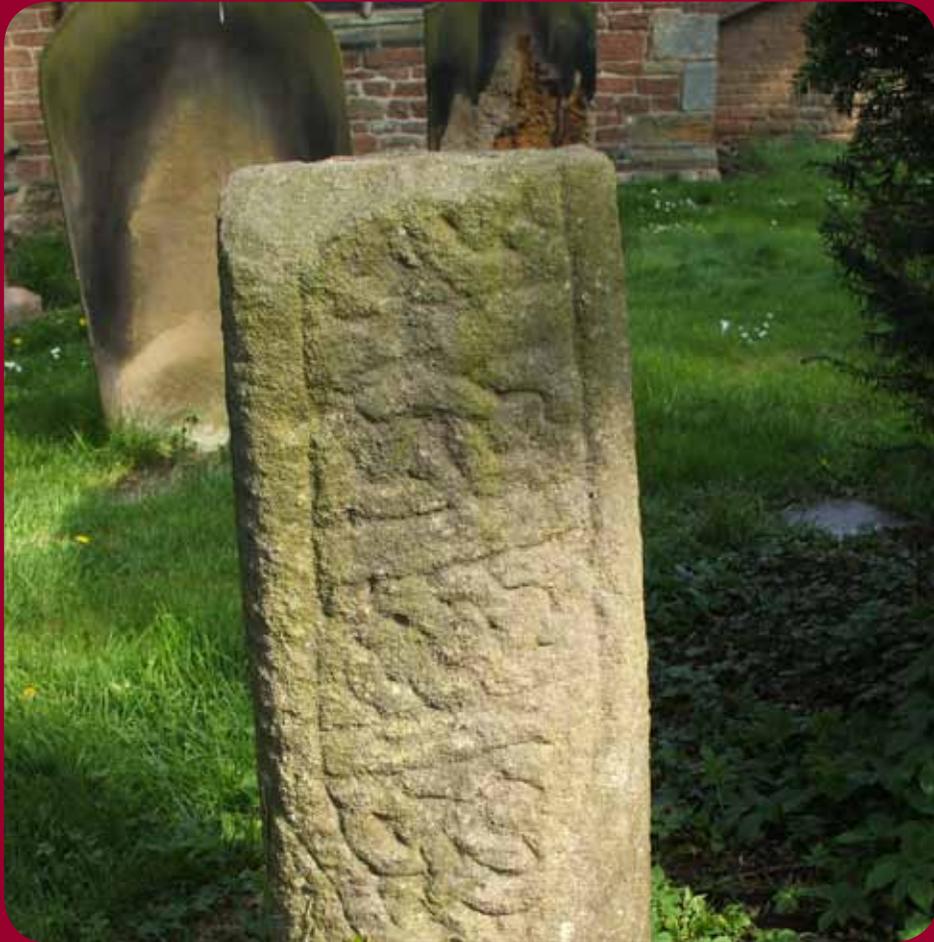
Anglo-Saxon Cross in St John the Baptist Churchyard

This cross fragment is among the gravestones in the churchyard. Other artefacts are scattered around this monument and included in the church porch, including a stone coffin.

The site appears to be in a stable condition with no immediate or urgent threats.

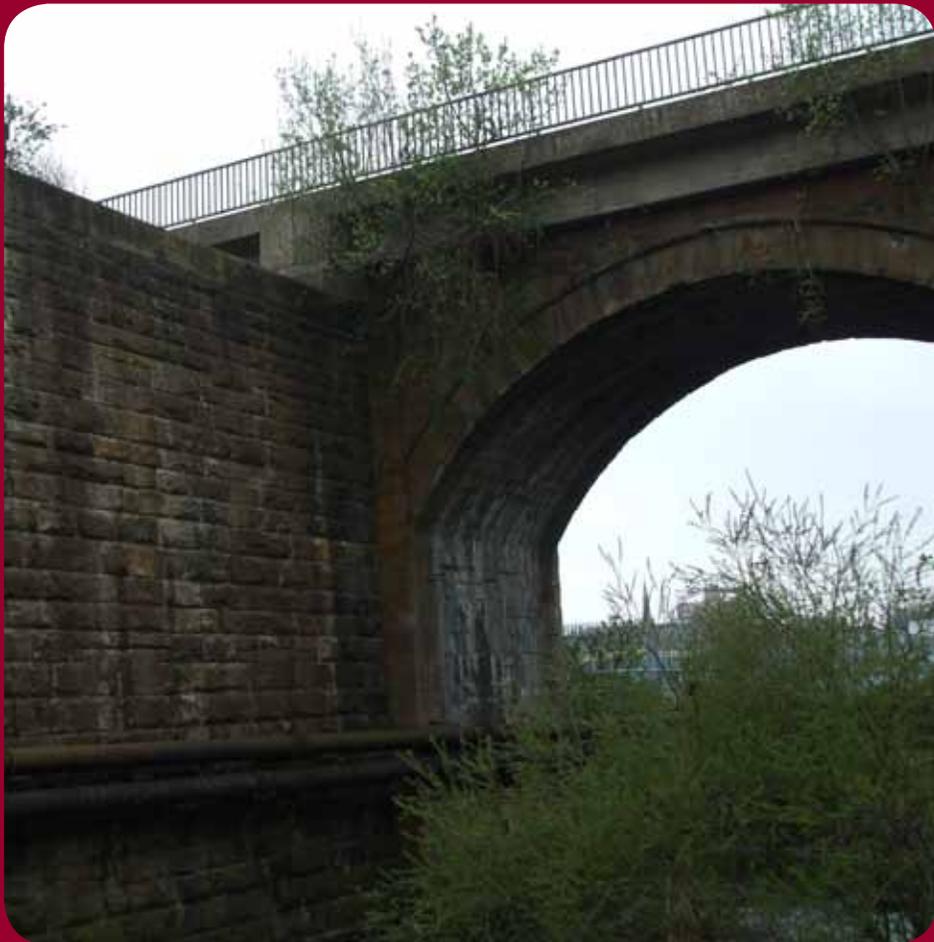
SITE OBSERVATIONS:
 The immediate vicinity of the bridge is of a poor quality and is cut off from the main pedestrian routes. As the bridge has a blocked arch access through is limited and the bridge lies at a dead end. Historically important both locally and nationally this monument has suffered vandalism and unsympathetic additions over the years.

CONDITION:
 The site appears to be in a stable condition, however vegetation may be threat in the long term.

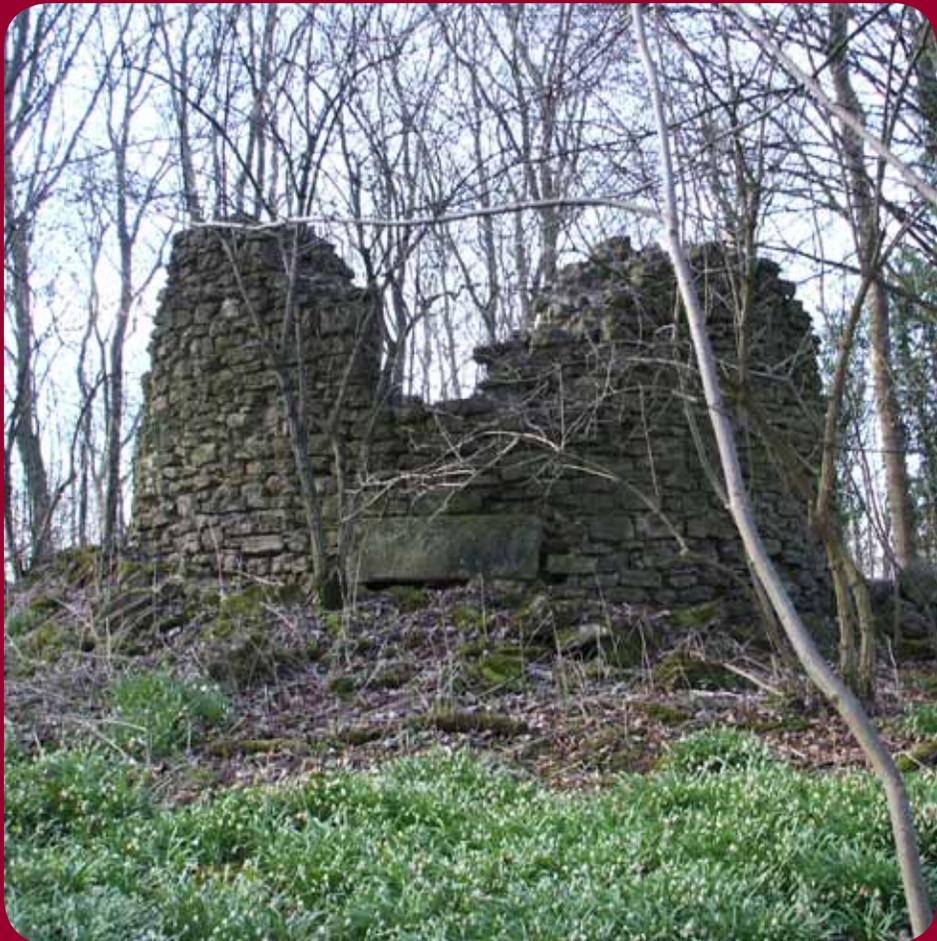
The site continues to be under threat from scrub and tree growth.

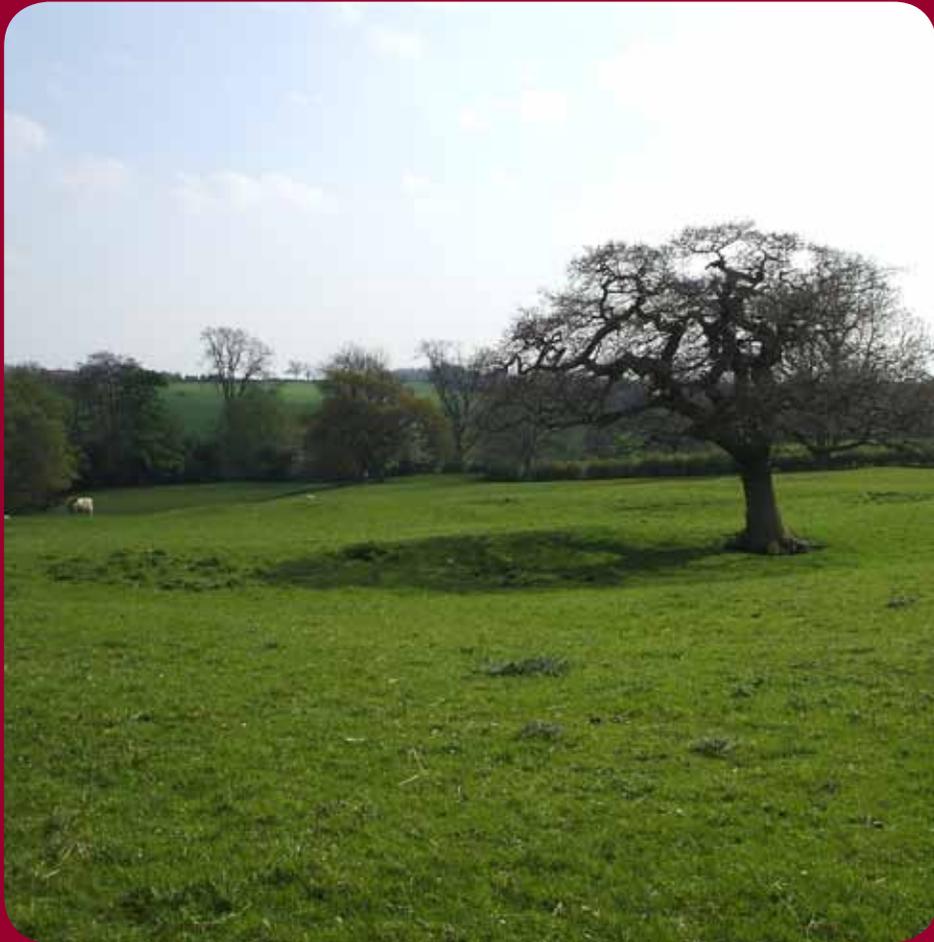
SITE OBSERVATIONS:
 Many of the features of this site are indistinct and eroded. Some evidence can be seen from the public footpath.

CONDITION:
 The site appears to be in a stable condition with no immediate or urgent threats.

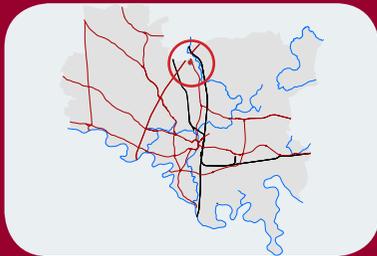
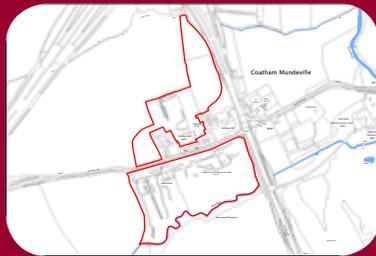
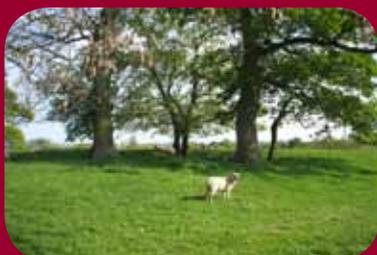
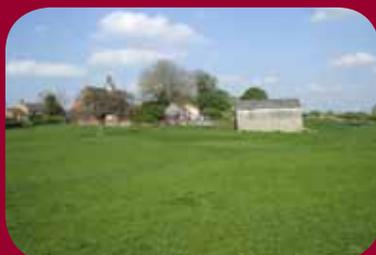
Many of the features of this site are indistinct and eroded. Some evidence can be seen from the roadside and lane that passes through the site to the village.

The site appears to be in a stable condition with no immediate or urgent threats.

Some interpretation materials would assist in understanding the deserted settlement.

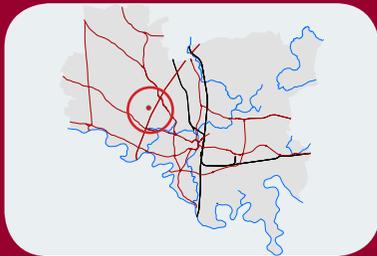
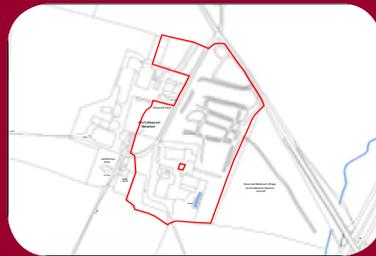
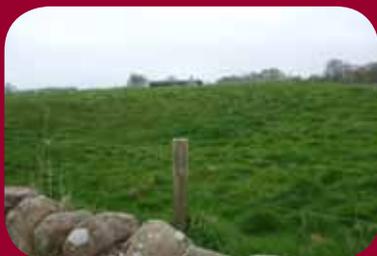
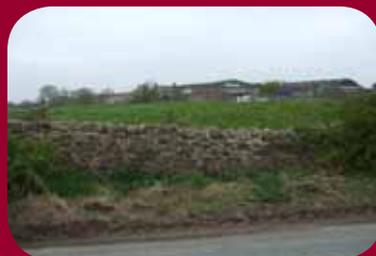
This site is an excellent resource and has many interesting features. The on-site interpretation material is good and facilities exist for parking. The site may be accessed from the village as well as along a track from the roadside.

The site appears to be in a stable condition with no immediate or urgent threats.

Clearer signage from the village centre would increase the visibility of this site and encourage more visitors, who may have come to see the village or use the farm shop across the green.

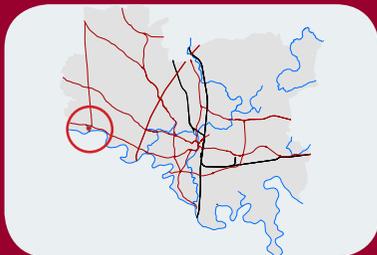
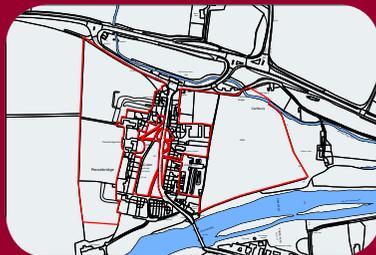
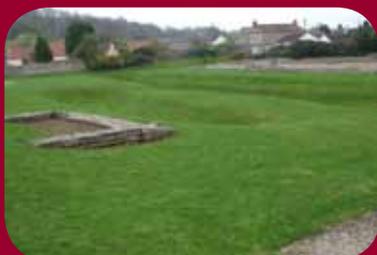
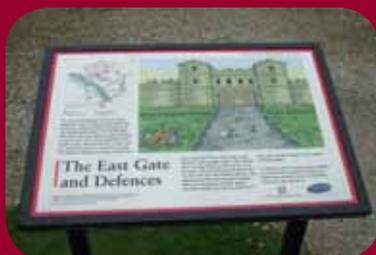
SITE OBSERVATIONS:
 The bridge is visible from a number of vantage points.

CONDITION:
 The bridge has suffered damage at river level and subsequent cracking. English Heritage have also identified vehicle damage as a risk.
 ★★☆☆☆

POTENTIAL IMPROVEMENTS:
 Some interpretative material would be a useful addition, especially as the bridge is still in use for traffic and pedestrians.

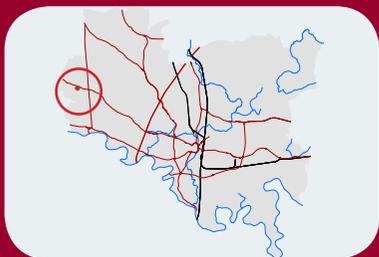
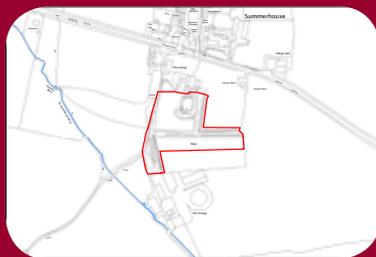
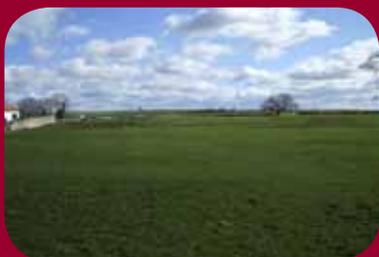
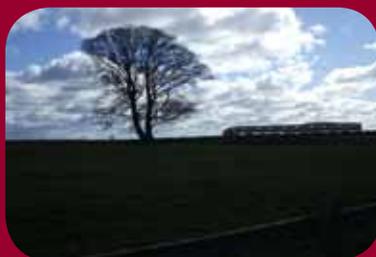
This site is visible from the road but has no access. It makes an interesting landscape feature that is apparent to the casual observer.

The site appears to be in a stable condition with no immediate or urgent threats. Ploughing appears to have ceased on the site.

Interpretative materials would be a useful addition at the field entrance. The site is in the same ownership as Ulnaby deserted village and there may be potential links.

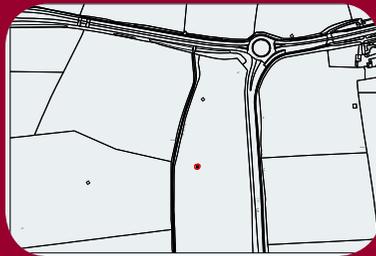
The site appears to be in a stable condition. Some damage to the brickwork is in evidence.
