VERIFICATION REQUIREMENTS FOR COVER SYSTEMS

Technical Guidance for
Developers,
Landowners and
Consultants

**Yorkshire and Lincolnshire
Pollution Advisory Group**

Version 4.1 – June 2021

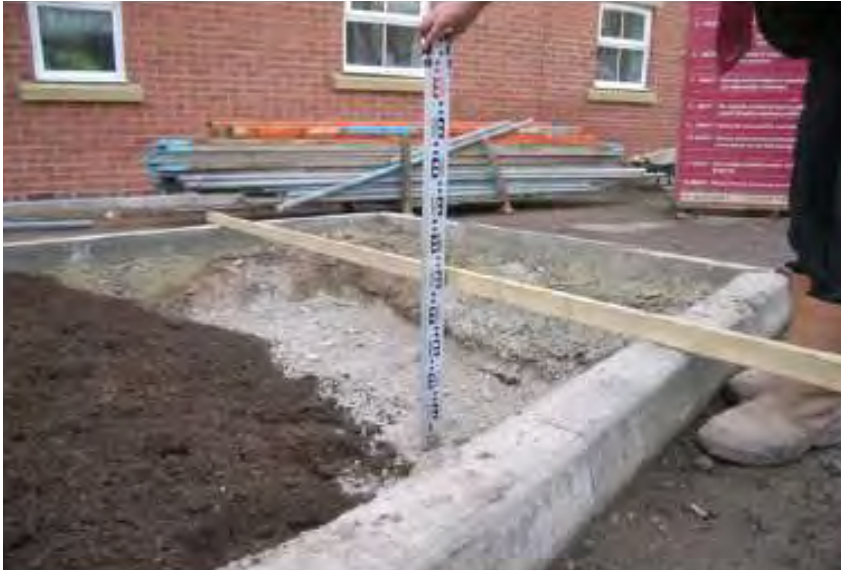
Photograph 1:
Depth check of inert
cover within area of
public open space.
Physical break layer
and topsoil visible.

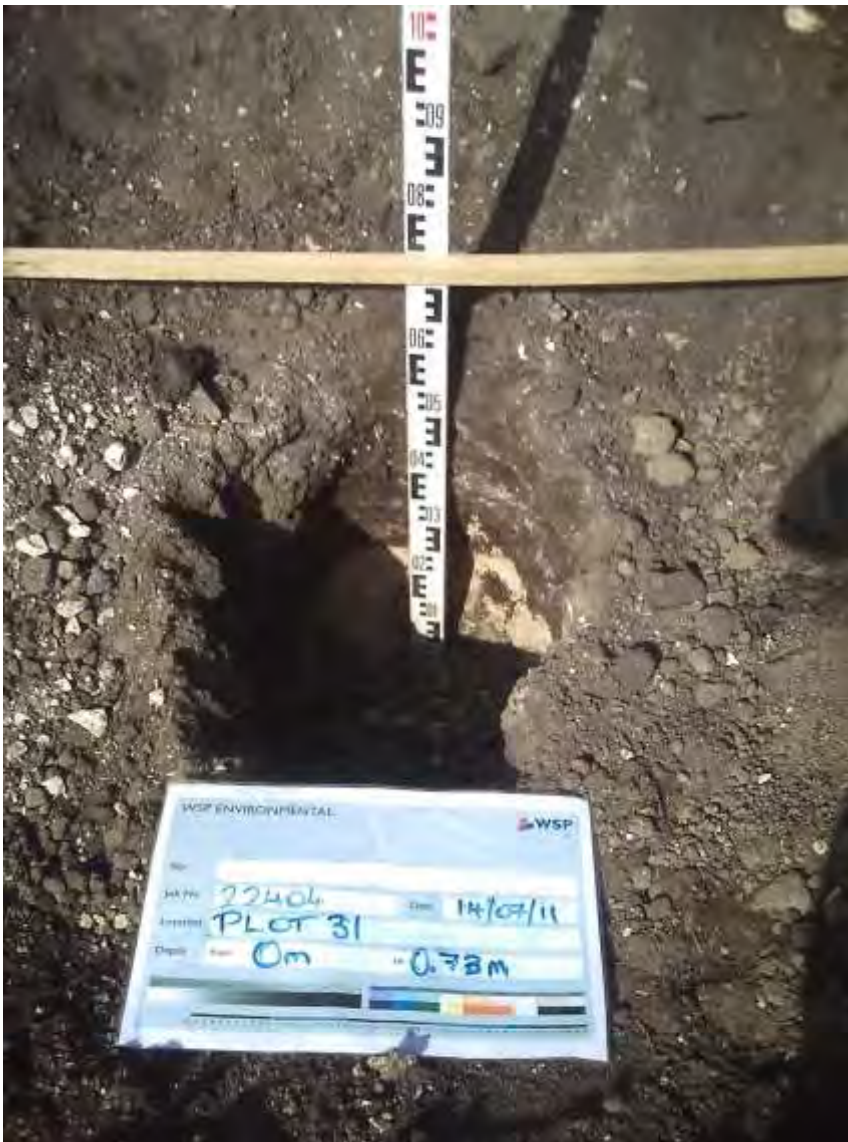
Photograph 2:
Depth check of inert
cover with Site &
Location Information
Board.

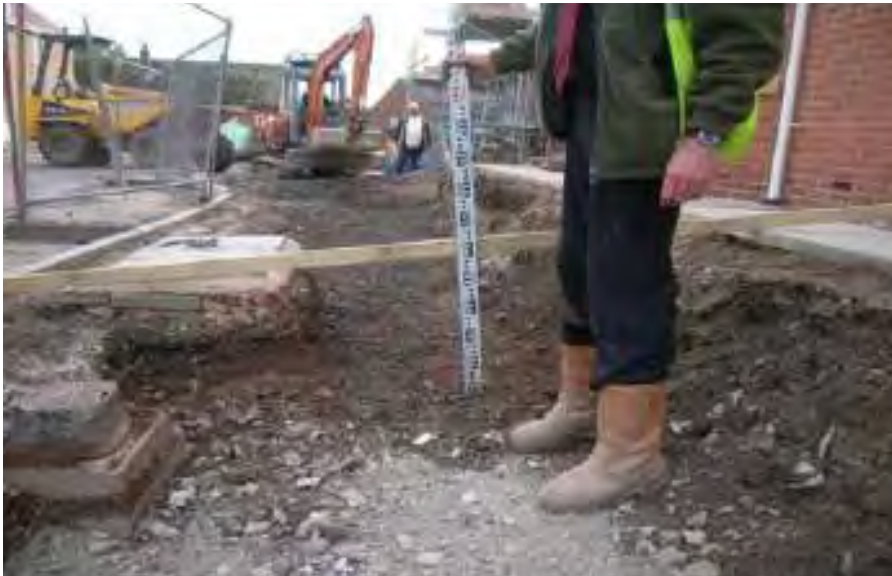
Photograph 3:
Depth check of inert cover within areas of front gardens.

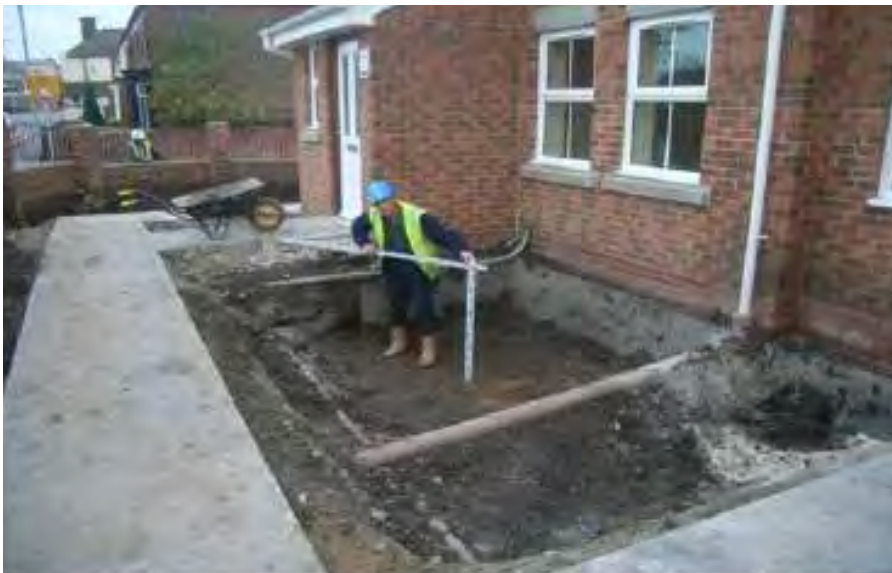
Photograph 4:
Depth check of inert cover within areas of front gardens.

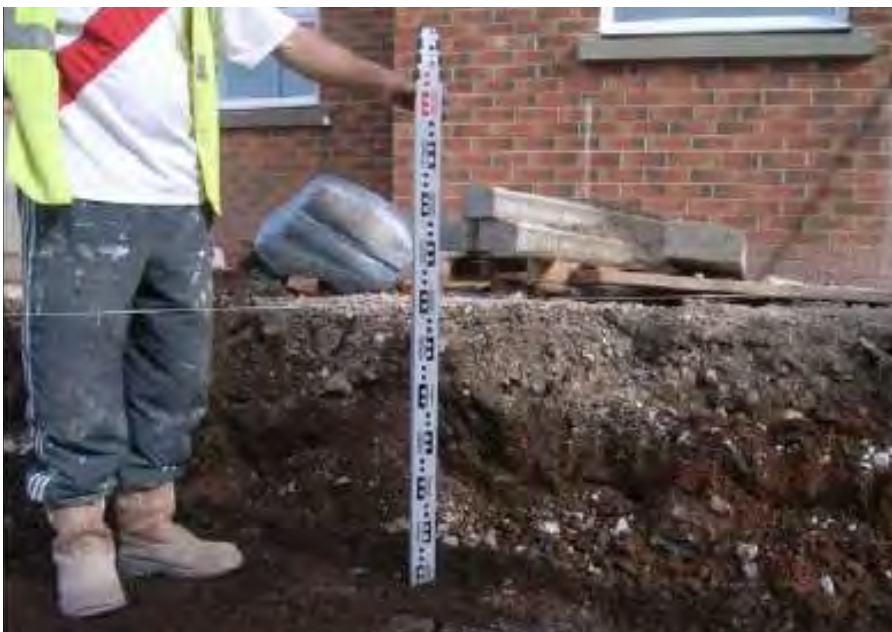
Photograph 5:
Depth check of inert cover within rear gardens. Taut string line spans across excavation.

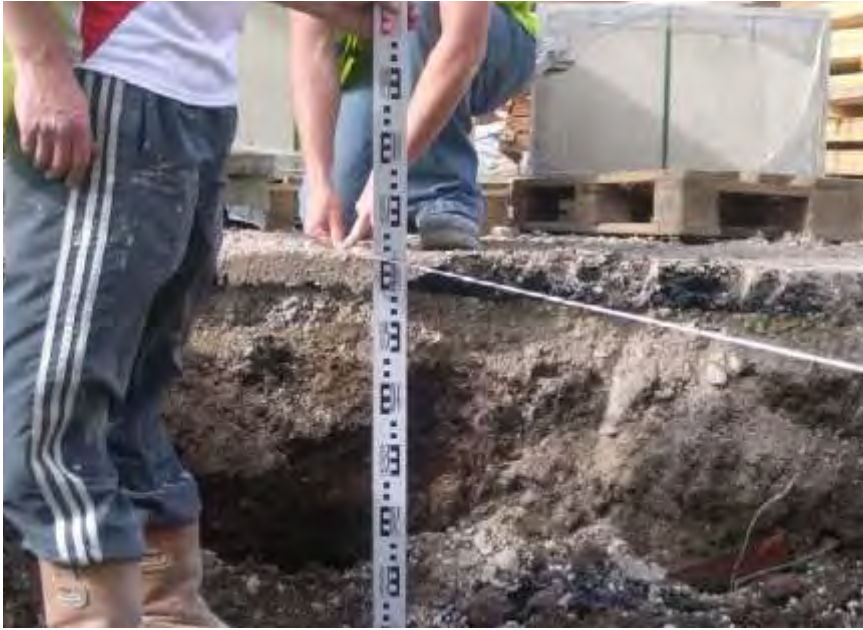
Photograph 6:
Depth check of inert
cover within rear
gardens. Taut string
line spans across
excavation.

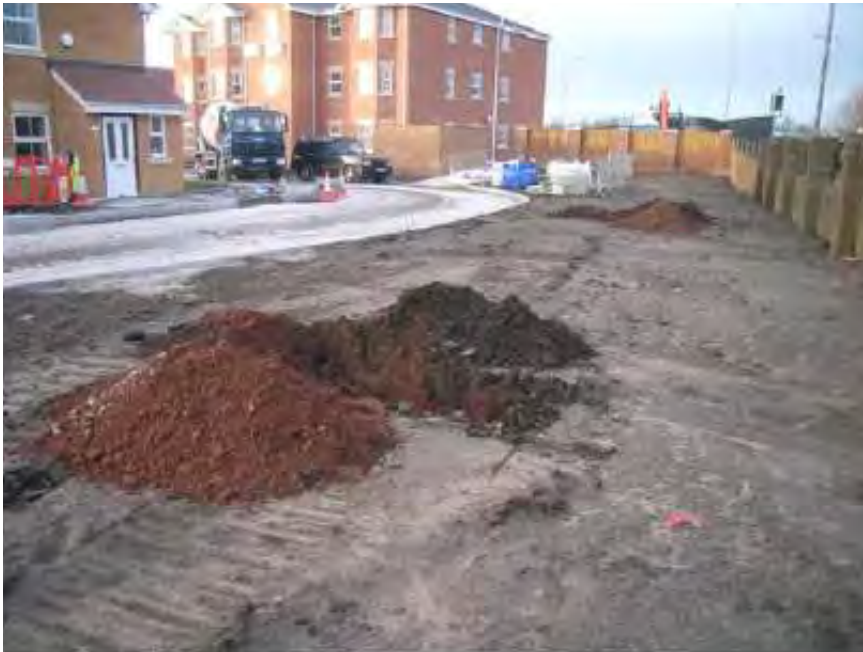
Photograph 7:
Shows the spatial
location of the
verification pit.

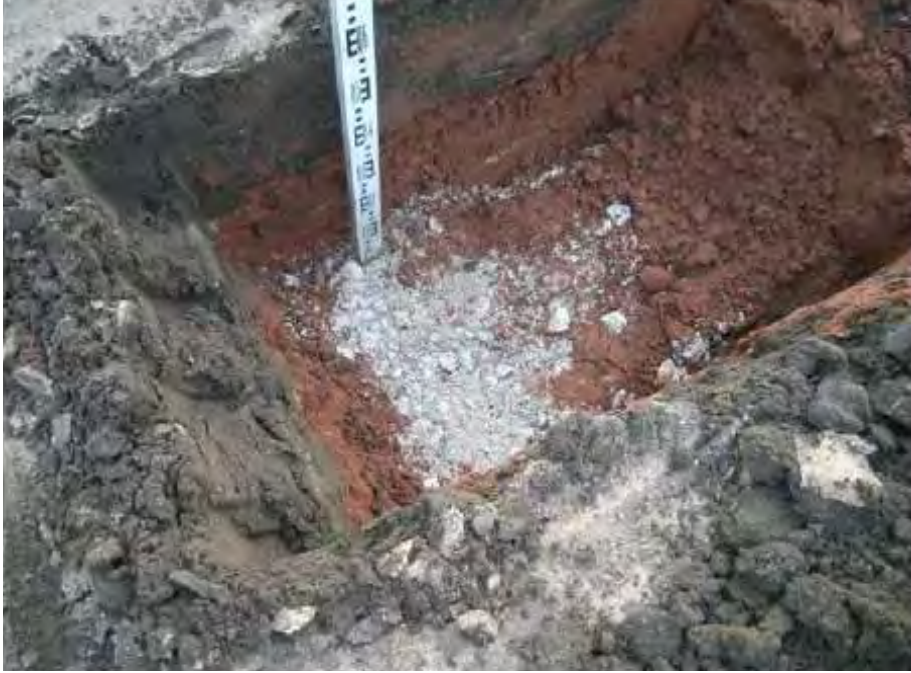
Photograph 8: Excavation within public open space and verification pit showing the presence of a remediation break layer at the base, a crushed sandstone inert fill overlain by topsoil.

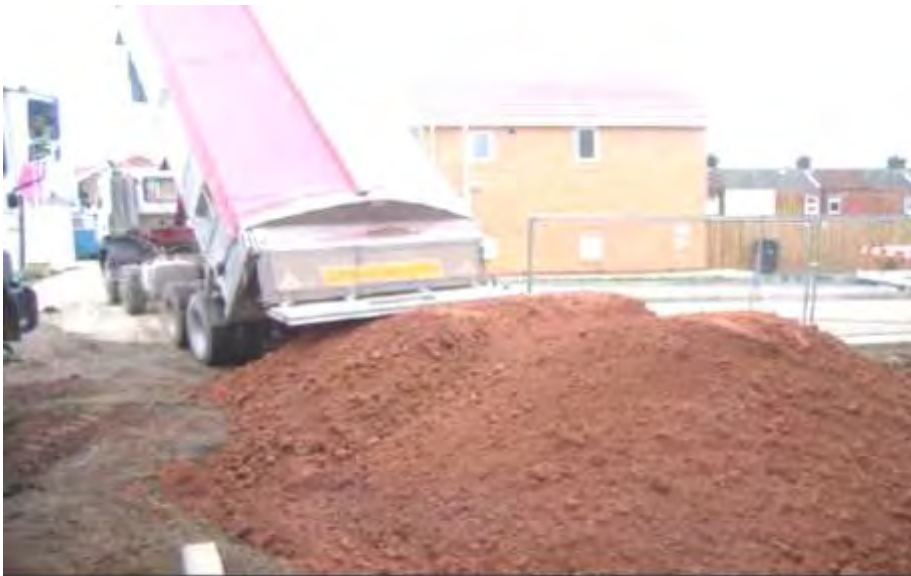
Photograph 9: Inert crushed sandstone being delivered. The spatial area of the remediation can be observed from these photographs (old terrace housing).

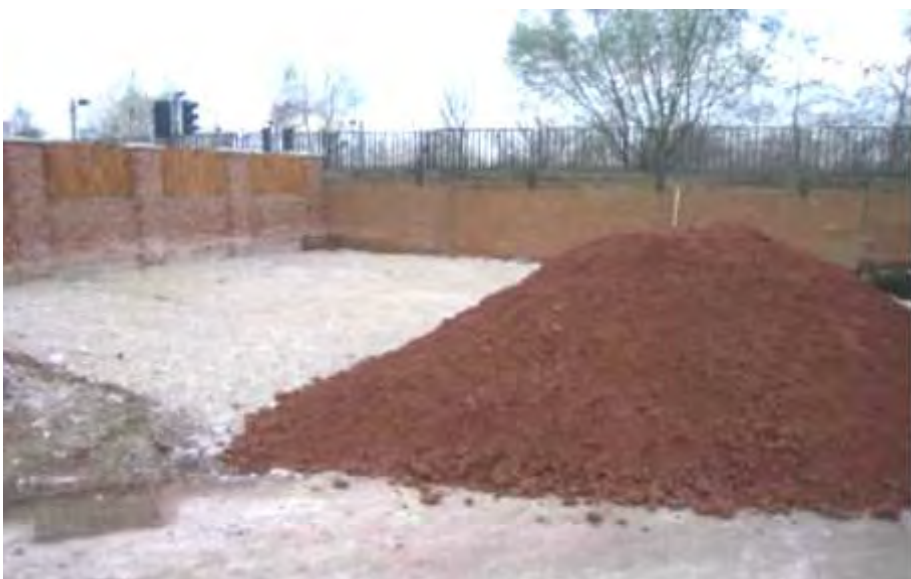
Photograph 10: Inert crushed sandstone being delivered with visible remediation break layer. The spatial area of the remediation can be observed from these photographs (traffic lights).

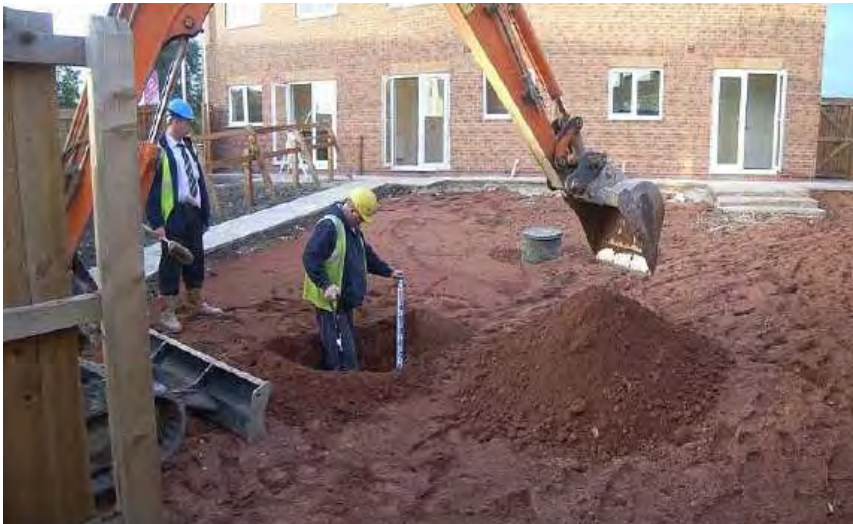
Photograph 11:
Shows the remediation of the rear garden, with a significant depth (1.0m) of inert cover. This photograph has been stitched to form a panoramic photograph and hence there is slight distortion

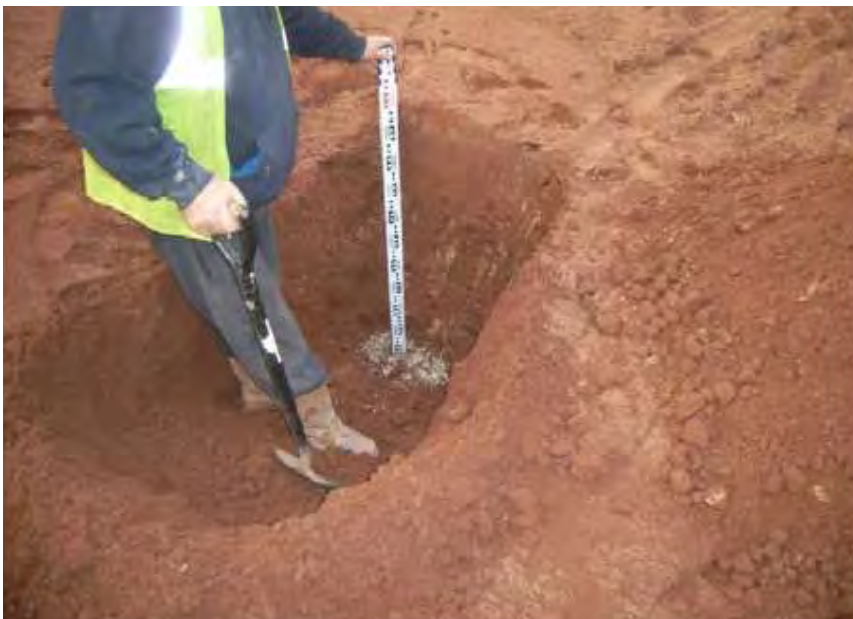
Photograph 12:
Shows the remediation of the rear garden, with a significant depth (1.0m) of inert cover. Remediation break layer visible at the base of the excavation.
